DOE LIBRARY
Daniel Ducoff

Introduction

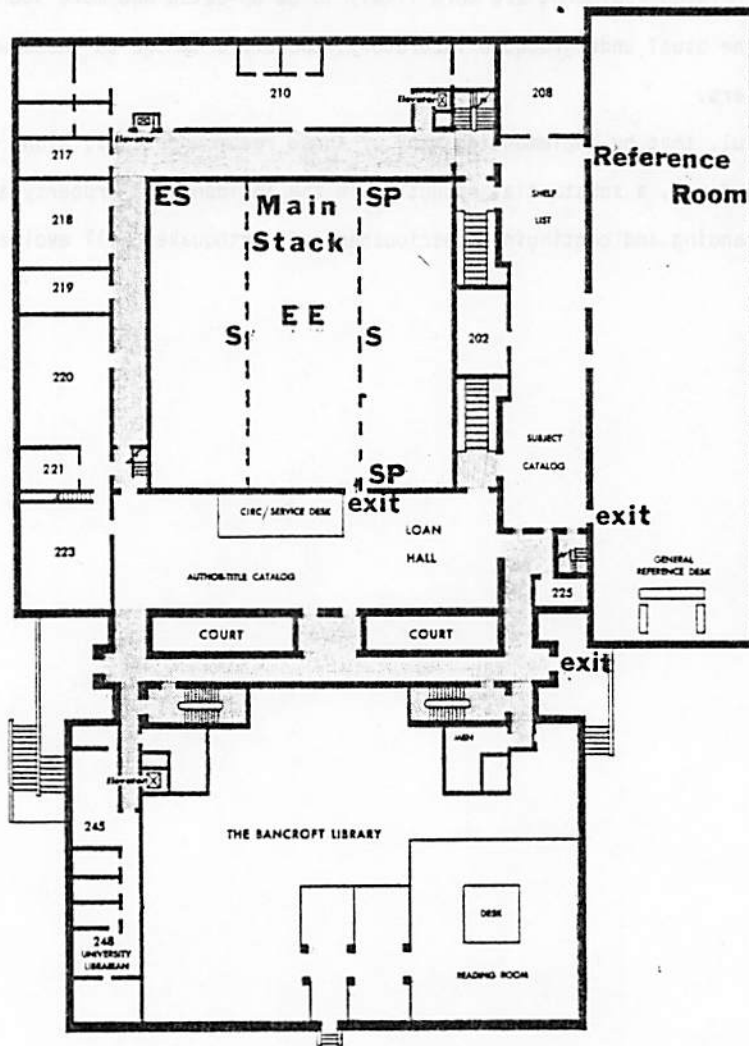
FIGURE 2. Main Library, Second Floor
 SOURCE: U.C. Berkeley Library Orientation
 Leaflet No. 1.

The one, commonly-used entrance for the Reference Room is divided into two gates surveyed by a book-detection scanner (FIGURE 2). There is an emergency exit to one side which can swing out to increase the width of the exit, but this is deceptively marked and is not immediately obvious. There is a corresponding door at the opposite end of the room used for emergency exit only. Both the regular and the emergency exits open onto the hall containing the subject catalogs. From there, there are two options when exiting. The most direct path is also the most hazardous. This route passes beneath dangerous parapets, and the nearby arched window presents a possible threat from falling glass. The other exit involves crossing the catalog hall, descending the main staircase, and passing out through the front exit which is also overhung by parapets. This exit is, however, larger and offers a lesser chance of exit-impeding congestion.

Exit routes should be clearly marked, as in the stacks, by yellow tape indicating quickest or safest routes.
