Chapter 1
PCBs AND GENERAL ELECTRIC IN OAKLAND

Nancy Woo

This report is about one such clean-up effort presently going on in the Bay Area. General Electric operates a transformer and repair plant in Oakland where an estimated 20,000 gallons of oil containing PCBs were spilled. My report gives a brief case history of the site and the clean-up effort being made. The Regional Water Quality Control Board (San Francisco Bay Region) has a detailed study on the General Electric Oakland Site on which much of this report is based.

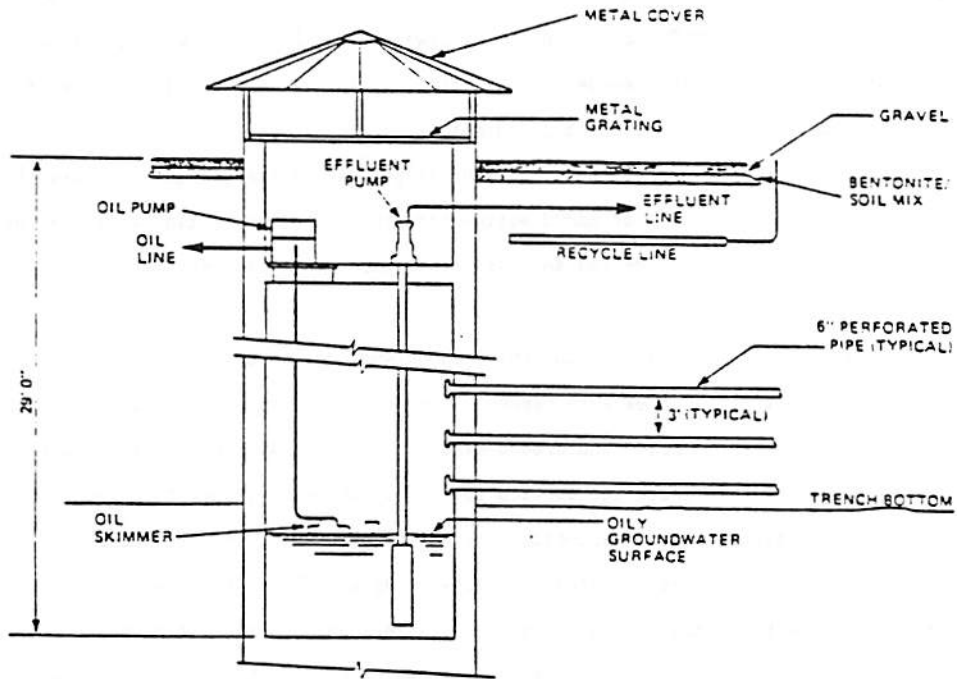
The greatest potentially harmful situation was the oil plume. There was concern that the oil plume would travel. Off-site migration of the oil would result in a greater area of contamination and would pose a public health threat. The system chosen to extract and immobilize the oil was the French-drain system (Figure 1). The French-drain contains three perforated pipes which empty into a central collection sump. The pipes are vertically separated from each other by about three feet, with the lowest pipes reaching a depth between 25-30 feet. Each pipe length varies from 60-80 feet

Figure 1. The French-Drain System
Source: RWQCB-C.

and has a diameter of 6 inches. Surrounding the pipes is drain rock which extends to about 1 foot of the soil surface. The drain rock is overlain by compacted fill and then covered with a surface seal so as not to permit infiltration into the drainage system. Water could not be allowed to infiltrate the subsurface soils in order to control the movement of the ground water and the oil plume. Three French-drains were used for this site.

The selection of the French-drains was based on conditions at the site. There was a shallow ground water table above the plume, and it was theorized that, initially, as the oil plume moved downward into the drains, the water table would drop (RWQCB-C). As the water level dropped, the vertical and lateral migration of ground water outside of the control area would be prevented and redirected towards the drains (RWQCB-F). Water flowing towards the drains would enhance the downward flow of the oil plume. The oil-water mixture would be collected by the pipes and drained into the central collection sump. Here an oil and water interface would be created which would enable one pump to remove the oil and another to pump the contaminated ground water to an on-site treatment facility. The oil would be stored on-site in 55-gallon drums for no more than 90 days, after which they would be taken to a Class-I landfill (RWQCB-C).

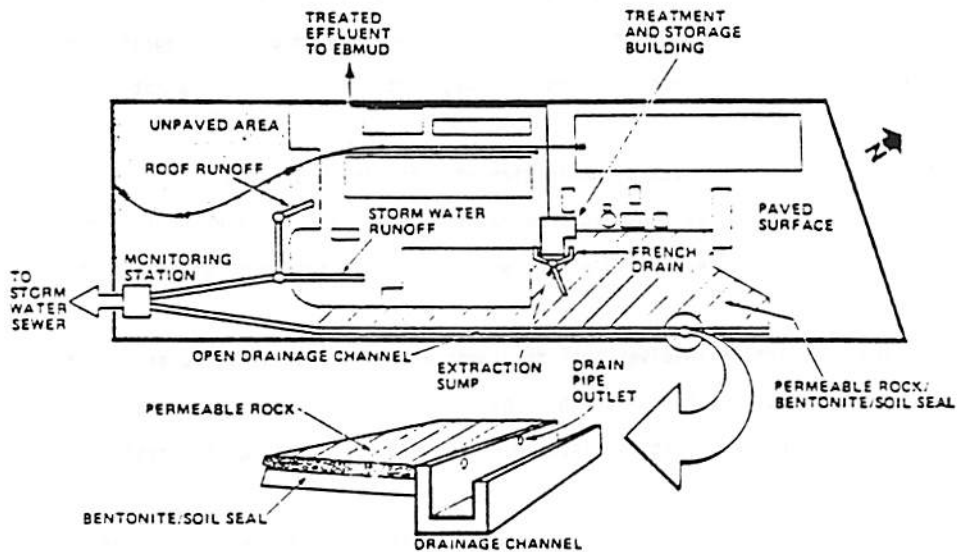
Other immediate mitigation measures concentrated on surface run-off control. There were four specific areas where control measures were needed: unpaved areas with or without PCB contamination, building roofs, existing paved areas, and around-site perimeters. All unpaved areas were altered so that run-off would not infiltrate the surface soils. Slopes were graded to direct run-off towards a drain site, covered with a Bentonite-soil impermeable seal, then topped with a layer of gravel. Run-off from rooftops was directed to catch-basins and flowed through buried drain lines. Curbs and more drains were placed around the site perimeters and other existing paved areas to prevent surface run-off (Figure 2). Collected run-off was monitored before it left the site in order to make sure it did not exceed the PCB standard average of 50 ppb.

The French-drain system has been partially successful. The water table levels prior to the installation of the system showed a significant drop. The directional flow of the ground water was reversed towards the French-drains. However, the quantity of oil and ground water removed

Figure 2. Drainage Control System - Oakland Site.
Source: RWQCB-C.

is much lower than anticipated. The system has the capability of recovering 14,000-15,000 gallons of water per month but is currently pumping 1,000-1,500 gallons of water per month and recovering 1 gallon of oil per month. GE claims that 20,000 gallons of PCB-contaminated oil has been spilled on-site, most of which is located in the subsurface oil plume. If the reported flow remains constant without any other type of mitigation, it would take approximately 20,000 months (= 1,667 years) to extract all the contaminated oil from the site.
