A QUESTION OF SETTLEMENT: EMERYVILLE'S LANDFILL PROBLEMS

Alison Pappe

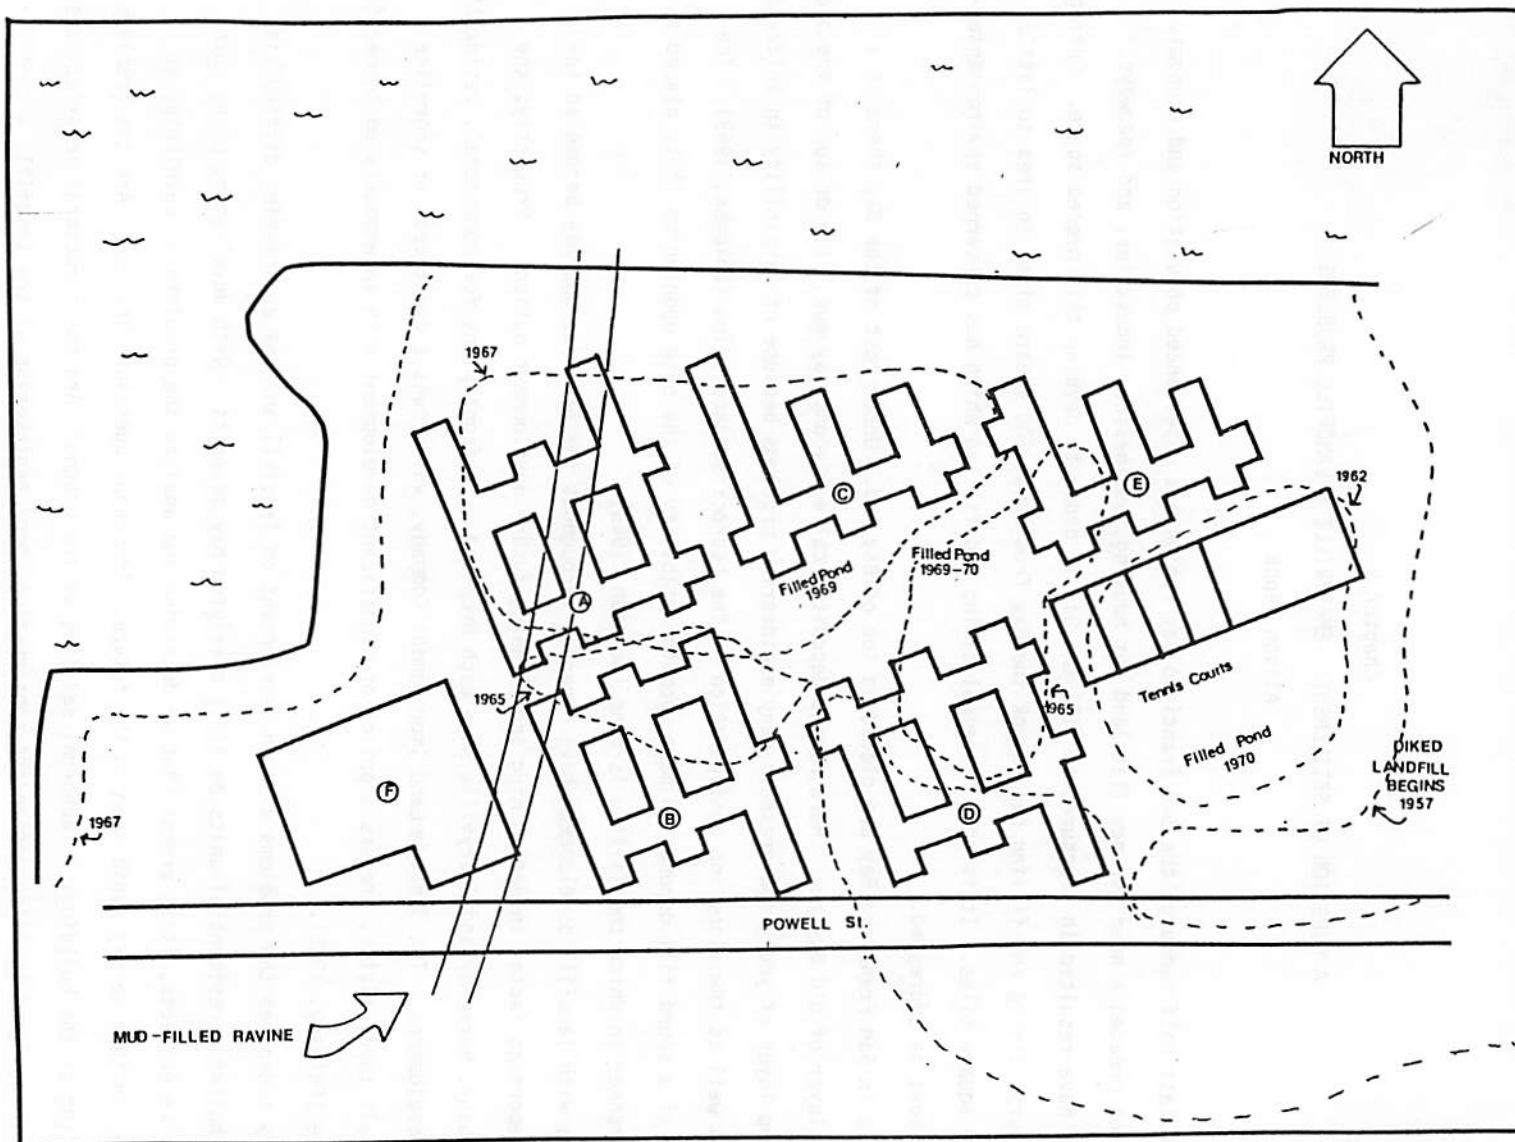
FIGURE 1

WATERGATE SITE PLAN

construction began. By late 1965, all of the dikes had been completed and most fill had been placed on the east and south parts of the site. As of 1969, three diked interior ponds under Buildings A, C, D and E (Figure 1), totalling about ten acres in area, remained to be filled; these were completed by February 1969 when the site was turned over to Lathrop Construction Company.

The final result of all filling operations as of mid-1969 produced about fifty acres of older fill about 25 feet thick, which had caused nearly normal consolidation of the mud beneath, except for in the ravine area (a wide band of very deep Bay mud) under Buildings A, B and F (Figure 1) on the west side of the site, in addition to the ten acres of recent pond fill.

Where the Bay mud is thickest, the settlements are the greatest. The thickest mud occurs in a buried ravine (50-70 feet wide, over 45 feet deep) located under paved areas under Buildings A, B and F, hence these areas experience the greatest settlement. The next greatest settlement area occurs under the ten acres of 1969 recent pond fill.
