Chapter 1  
THORNTON BEACH LANDSLIDE:  
A CASE STUDY IN COASTAL DEVELOPMENT  
Paul Berkowitz

In this report I use the Thornton Beach landslide to illustrate the geologic hazards of coastal development in unconsolidated sedimentary rock. I will do this in two ways. First, I will describe the past impact of the landslide upon development; and second, I will map the erosion of the past 15 years in order to illustrate recent damage and to predict future damage.

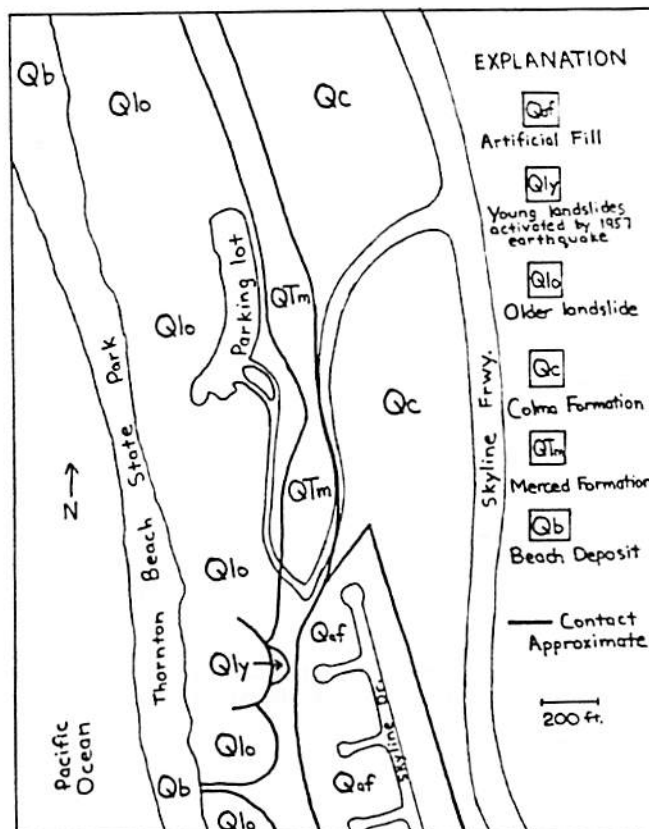
The geology of the South San Francisco quadrangle, including Thornton Beach (Figure 3), was mapped by Bonilla (1959). Two different formations as well as artificial fill exist near Thornton Beach. The youngest formation is the Colma Formation, a "friable, well-sorted fine to medium sand containing a few beds of sandy silt, clay, and gravel" (Bonilla, 1971). The older Merced Formation has similar properties to the Colma Formation, except that it is a little firmer, and more resistant.

Figure 3. Generalized geology of Thornton Beach.  
Source: After Bonilla (1959).

The artificial fill, as well as the silt and clay of the Colma Formation, create local variations in rock density and porosity. These variations often channel water flow, creating ideal surfaces for rotational slumps. In addition to the erodible properties of these formations, the Merced Formation tilts steeply below the horizontal Colma Formation. This factor adds more instability to the region.

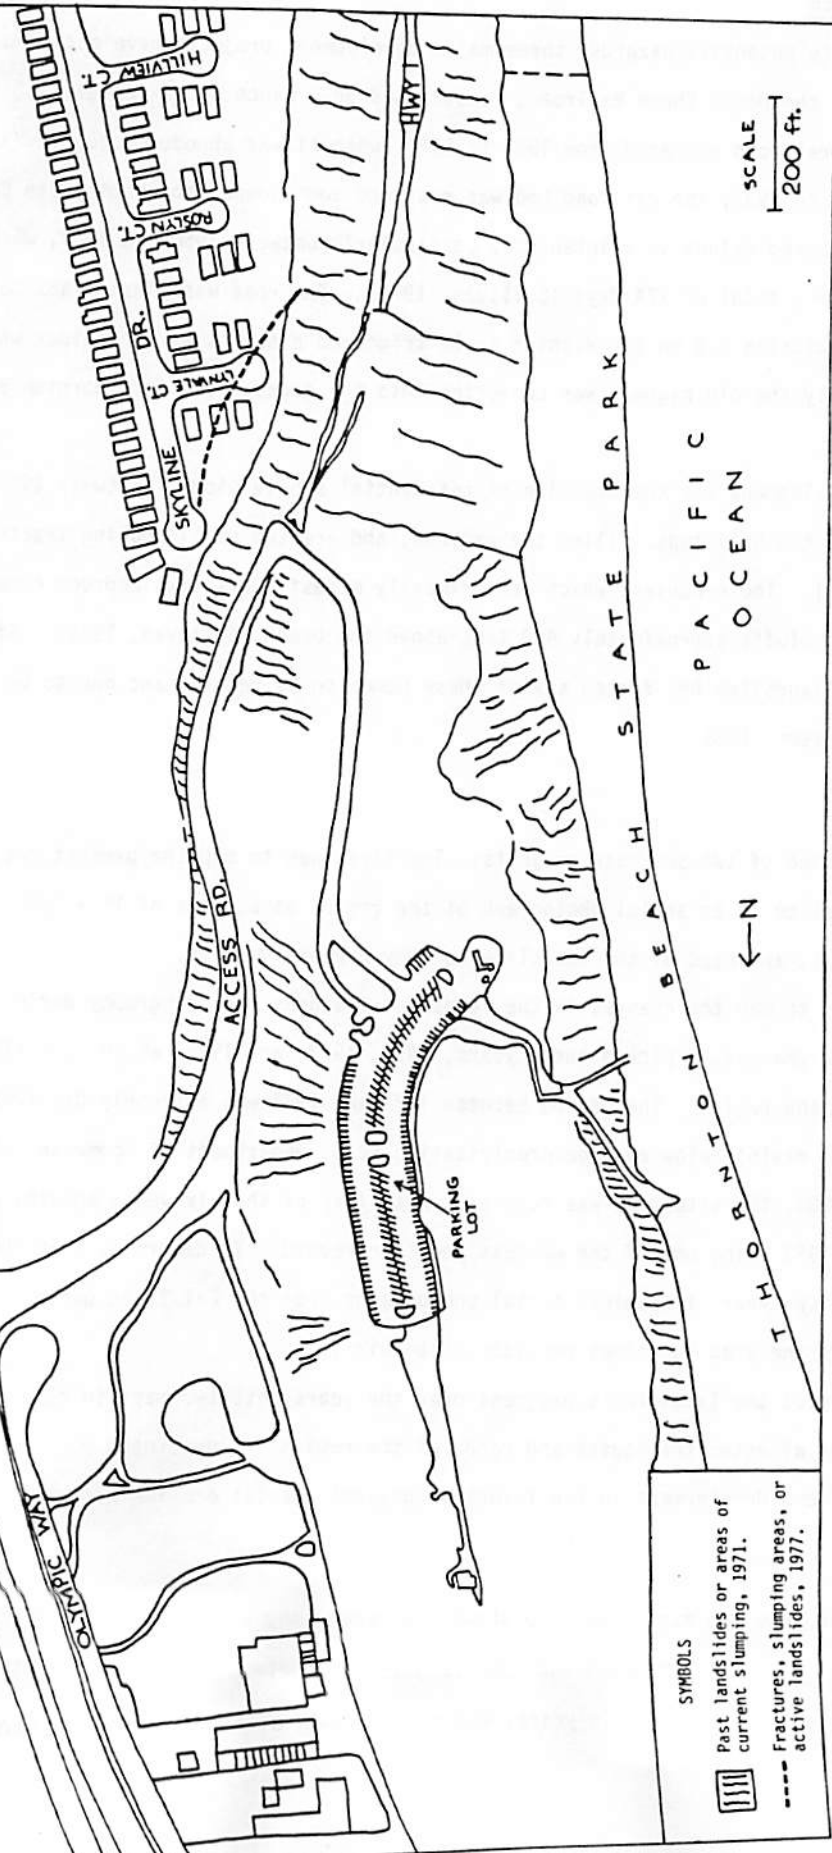
The data are condensed into two maps: one map shows the topography of 1971 and 1977 (Figure 4), and the other map shows the topography of 1983 and 1986 (Figure 5). Between 1971 and 1977, the dry years, few changes occurred. In both of these years, the region south of the access road shows

Figure 4. Map of landslides, 1971 and 1977. Note that the only difference between 1971 and 1977 is a fracture across Lynvale Court (upper right).

landslides and slumping above and below old Highway 1, which is about half-covered with debris. Minor sliding then continues along the State Park access road, with a major slide existing above the parking lot. In both 1971 and 1977 landslides and slumping occur along the length of the beach in the lower part of the bluffs. The one difference between 1971 and 1977 is a major fracture which developed across Lynvale Court. By 1975 the fracture was great enough to force the removal of three houses on Lynvale Court (cf. Figures 4 and 5).

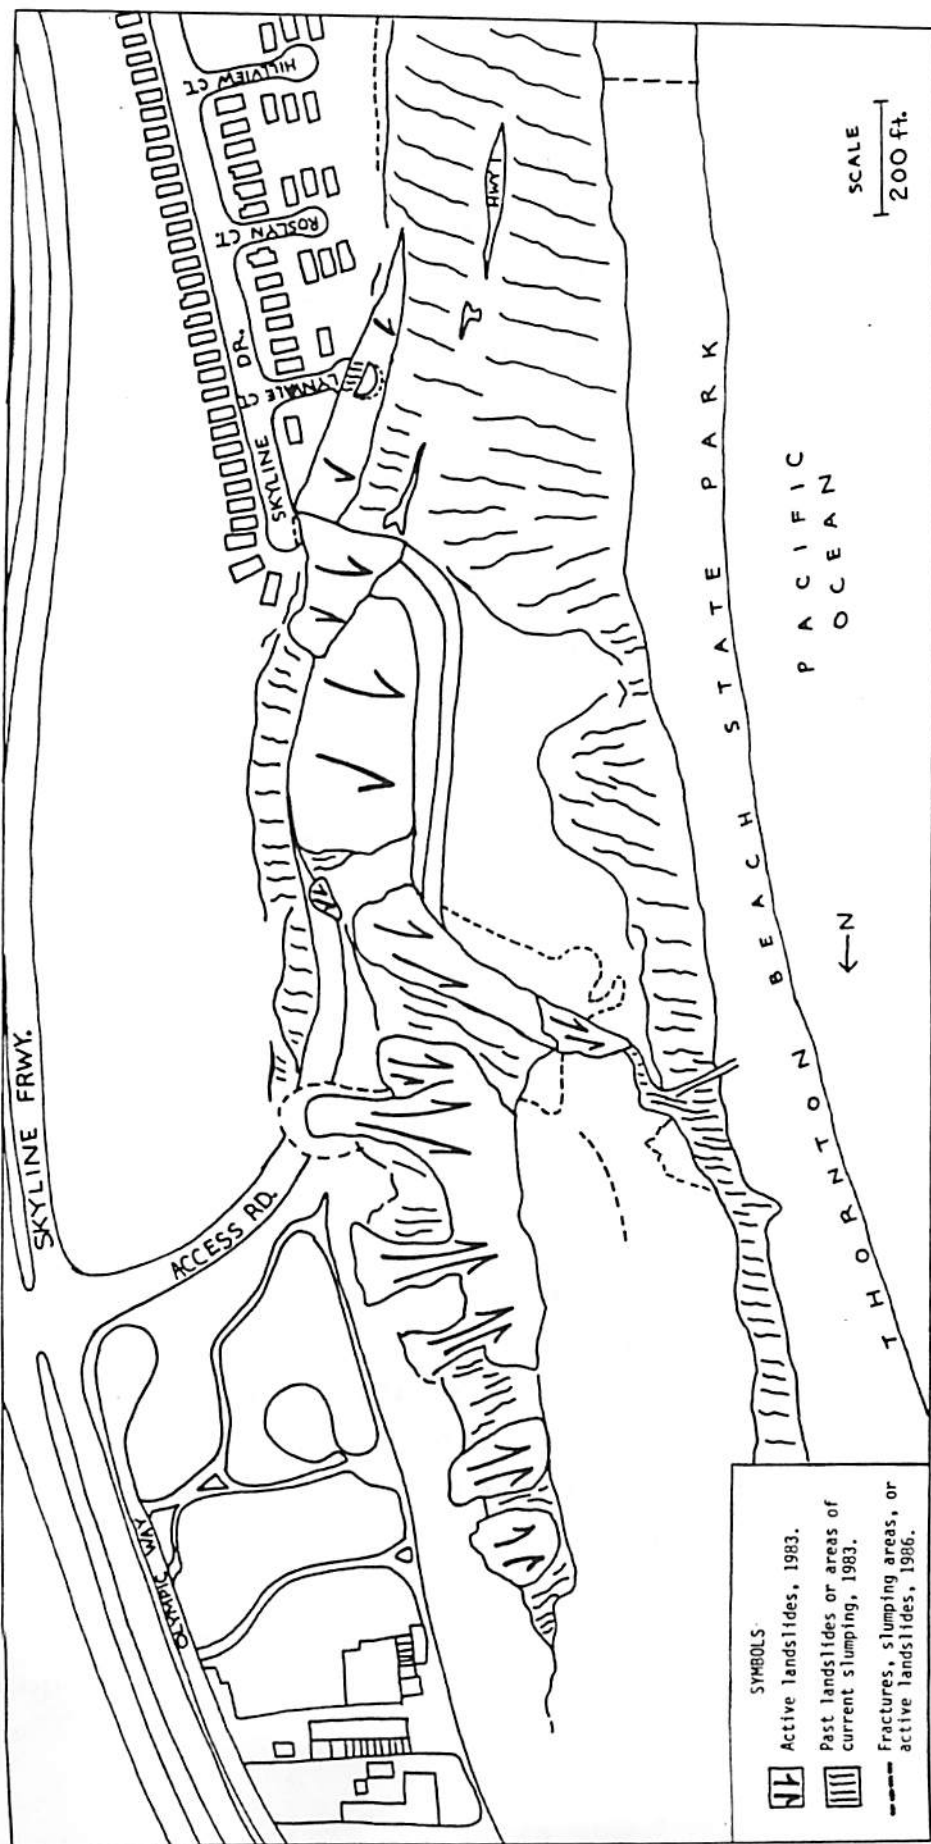
Figure 5. Map of landslides, 1983 and 1986.

Unlike the relatively stable period between 1971 and 1977, the winter of 1983 produced dramatic changes in the topography of the region (Figure 5). In January of 1983, everything to the west of the fracture across Lynvale Court slid down the hill, leaving a vertical scarp along the former fracture and dropping the cul-de-sac of Lynvale Court about 20 feet straight down. The fresh scarp face continues north of Lynvale Court and comes right to the edge of the Skyline Drive cul-de-sac. The position of landslide debris in this region is clearly observable by examining Highway 1, which is, compared to 1977, almost completely buried with earth.

Also in 1983, a large slump block just north of Skyline Drive destroyed the access road and deposited debris on top of the parking lot. In one section of the access road, the slump block dropped

as much as 21 feet (Lajoie and Mathieson, 1985). A series of connected landslides to the north of the access road also helped to bury the parking lot.

By 1986, after an extremely wet February (Table 1), the boundaries of the landslide had expanded along the south end of the parking lot and along part of the access road. The cul-de-sac of Lynvale Court also slid several more feet down the bluff. In addition to the expanding boundaries of the slide, fractures developed west of Roslyn and Hillview Courts, across the west edge of the Skyline Drive cul-de-sac, and west of the Thornton Beach parking lot.

The most obvious site for a future slide is at the cul-de-sac of Skyline Drive. On the west side of the cul-de-sac, a sharply undercut and extremely unstable scarp marks the head of the landslide. Just to the east of this scarp face, the pavement of the cul-de-sac has several fractures in it. These fractures are likely to become the future boundary of the landslide. As this occurs, part of the cul-de-sac as well as one house are likely to be damaged. The boundary of the landslide is also likely to move headward to the fractures west of Roslyn and Hillview Courts. The houses on these streets do not appear to be in imminent danger, but ultimately may be endangered. The other fracture which lies west of the parking lot does not appear to threaten any man-made structures. Another potentially dangerous region is the area west of Olympic Way. Although no fractures have developed, the area is capable of eroding rapidly without any warning signs as it did in 1983.
