The Effects of Stream Restoration on Habitat Quality

Lisa Hauck

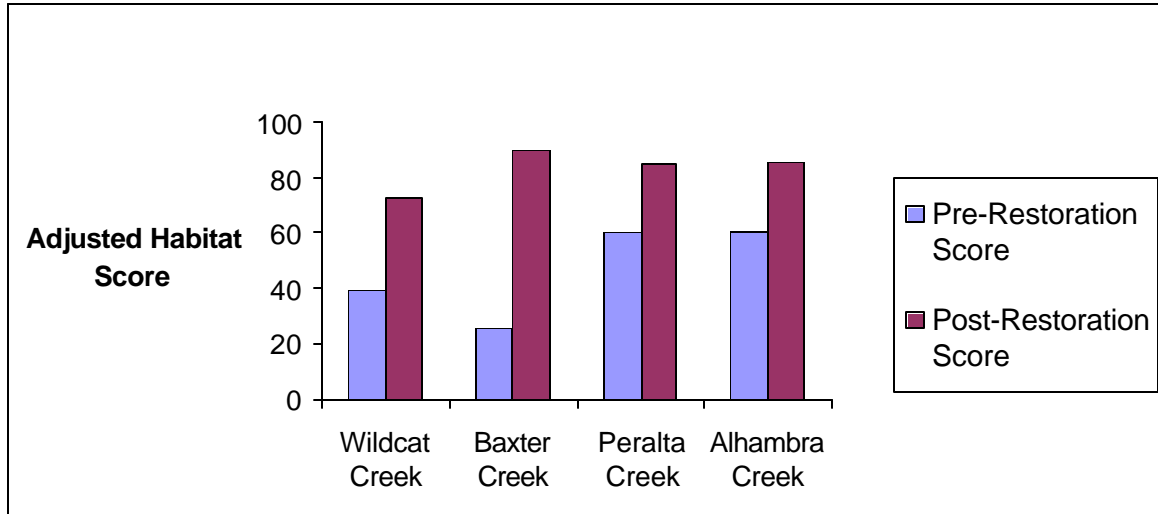
When comparing habitat quality of restored streams to their pre-restoration conditions, all of the restored sites showed improvement in habitat quality score (Fig. 5). Scores for all parameters measured in Wildcat Creek (Table 2) improved or remained the same after restoration. Condition categories prior to restoration ranged from poor to suboptimal prior to restoration and from poor to optimal after restoration.

Figure 5. A comparison of habitat quality before and after restoration in the four studied creeks, adjusted to only account for parameters measurable for both conditions.
