## **Restoration Recommendations for Fish Species Re-population of Strawberry Creek based on High Flow and Stream Habitat Assessment**

**Cheryl Lee**

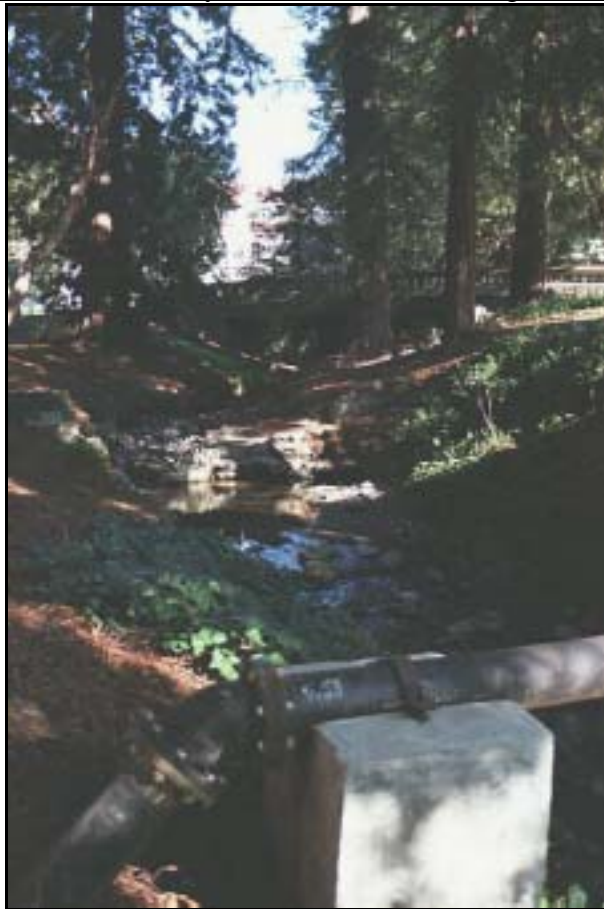
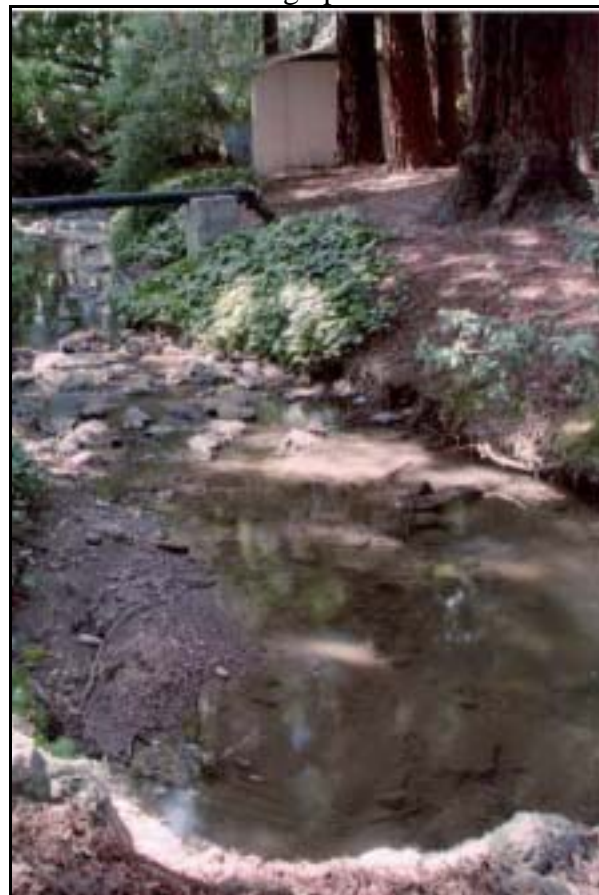
Site 3: South Fork – Valley Life Sciences Building, Redwood Grove

**Flow Diagramming** Only two high flow refuges were noted in the six sites along Strawberry Creek that were sampled. One refuge was at the South Fork – Valley Life Sciences Building site. A pool has developed along the left side, immediately after a failing check dam. During testing, mushrooms and orange peels were able to repeatedly avoid the rushing water by taking shelter in the pool. The other refuge was located at the North Fork – Valley Life Sciences

Due to the substantial number of “poor” habitat conditions and significant difference in base and high flows several restoration projects and suggestions can be made. The pool refuge located at the South fork – Valley Life Sciences Building site is a simple design that could be implemented at several locations along the creek. The pool that is present is actually a consequence of a failing check dam. On the downstream side of the check dam, the bank has begun to cut away creating a pool and shelter from high flows. Another possibility at the beginning of the study was to implement more culvert bypasses like at the South fork – Sather Gate site. However, during the storm when the high flow data was collected the bypass did not seem to be functioning at its intended purpose. Instead of the high energy water flowing through the box culvert, it was all flowing around the meander bypass. So, for the culvert/bypass structure to work, the creek would have to be flowing at an even higher magnitude. Yet, the flow difference between base and high flow was already substantial. A possibility would be to create a similar design, but on a smaller scale. A natural variation is oxbow formations along creeks where water is allowed to meander, yet at times of higher energy flows water can travel in more direct routes. However, a more natural meander may be difficult in many areas of campus due to the limited space and close development of the campus.

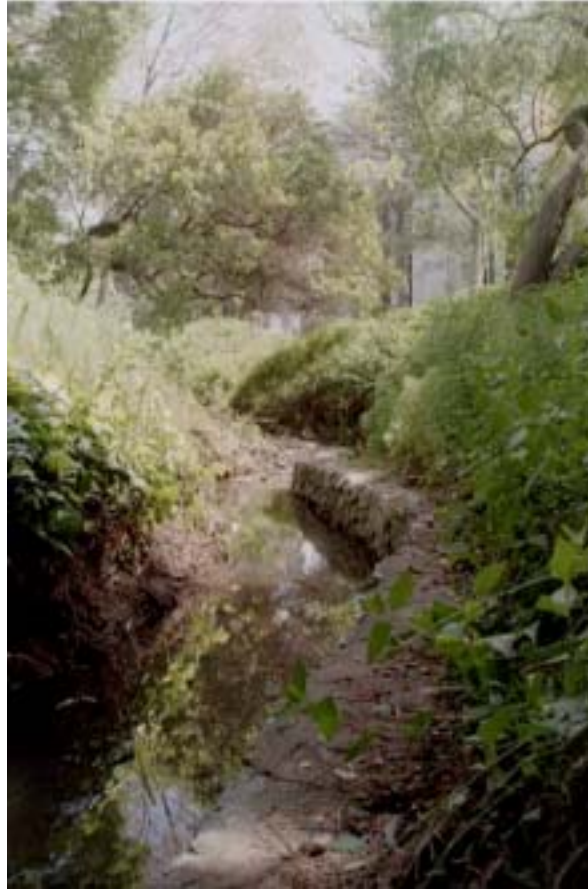
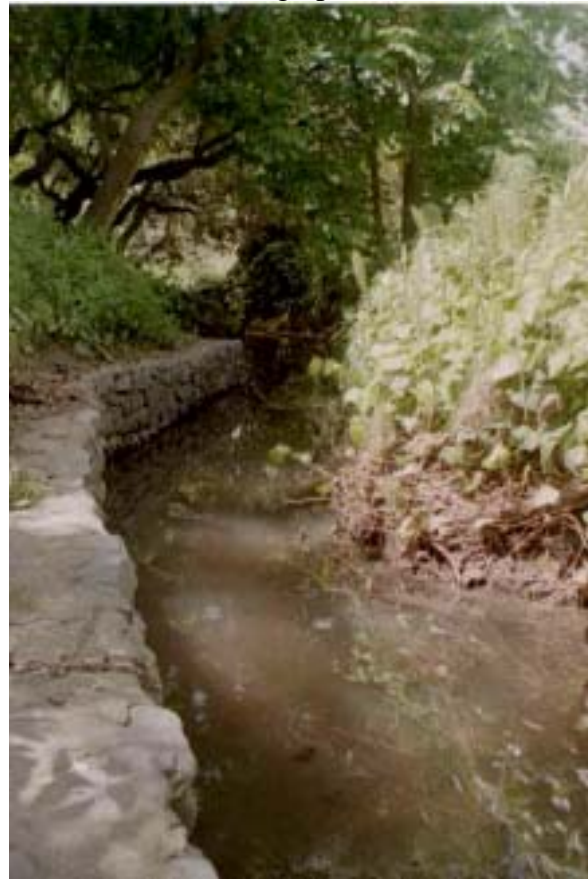
Site 6: North Fork – Valley Life Sciences Building

Building site. It was the same area that had considerably slower flow even at normal flow times, along the left bank, near the beginning of the site stretch a back eddy, back current, formed creating a high flow refuge. However, at all of the other sites, no refuges were noted. Diagrams of flows are attached in Appendix B.
