Hydrologic Investigation of Concrete Flood Control Channel at UC Berkeley's Richmond Field Station

by Patrick Nichols

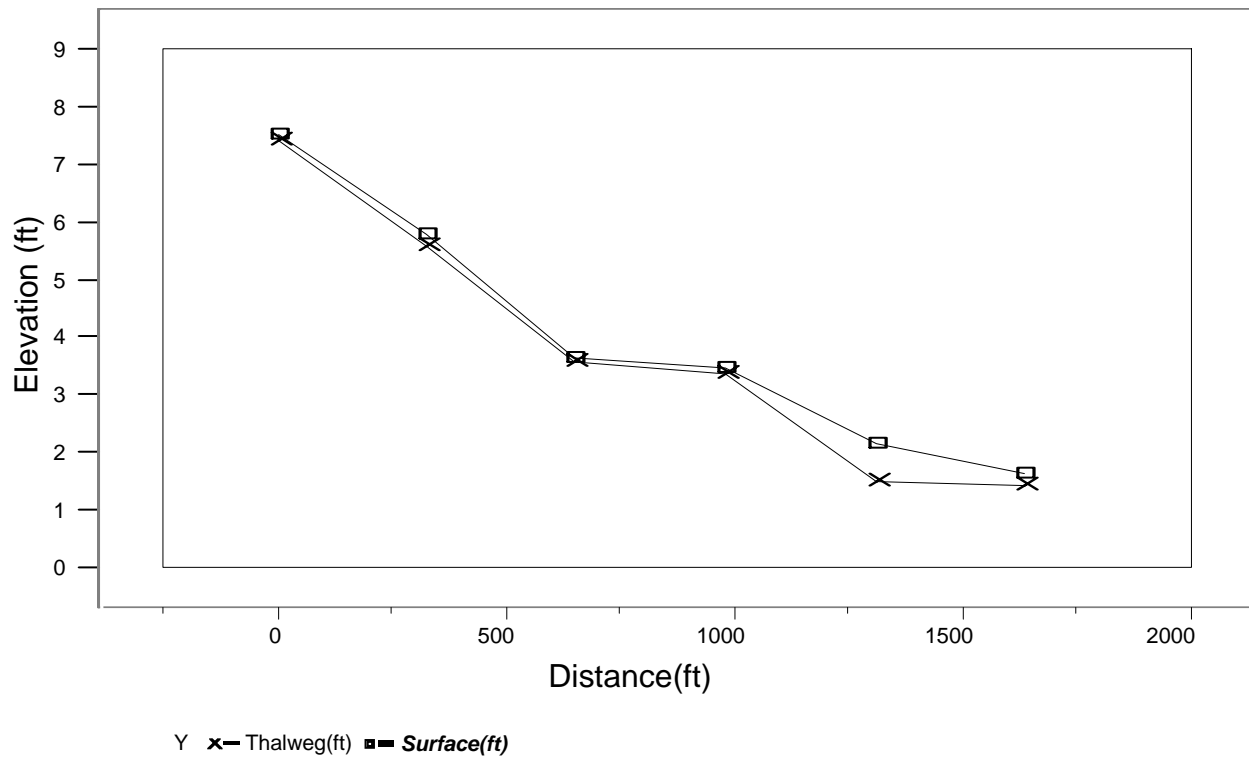
The surveying concluded that the channel has a slope of approximately 0.36% and a length of 1660.21ft from the culvert opening to the point at which it meets the marsh. The cross sections show a uniform shape over most of the channel (appendix A). The long profile reveals the channel does not slope evenly and flattens out in places creating deeper water, which we observed when walking the channel (fig 1).

Fig. 1: Longitudinal Profile

it could be successful as a stream corridor. During the study we observed the channel exploding with submergent and emergent vegetation/algae during the spring. Many waterfowl were observed using the channel for refuge, as well as a few small fish. Frogs/toads of some sort were heard and what appeared to be amphibian eggs were seen. The fact that this channel already has a thriving aquatic ecosystem implies that it would be a great candidate for riparian creation. It should also be noted that while this study was focused on the system as a fresh water input to the salt marsh, so no measurements of tidal effect were taken, the tide from the bay was observed influencing the channel over 740 feet up from the marsh, indicating that section of the channel is part of the tidal marsh itself.

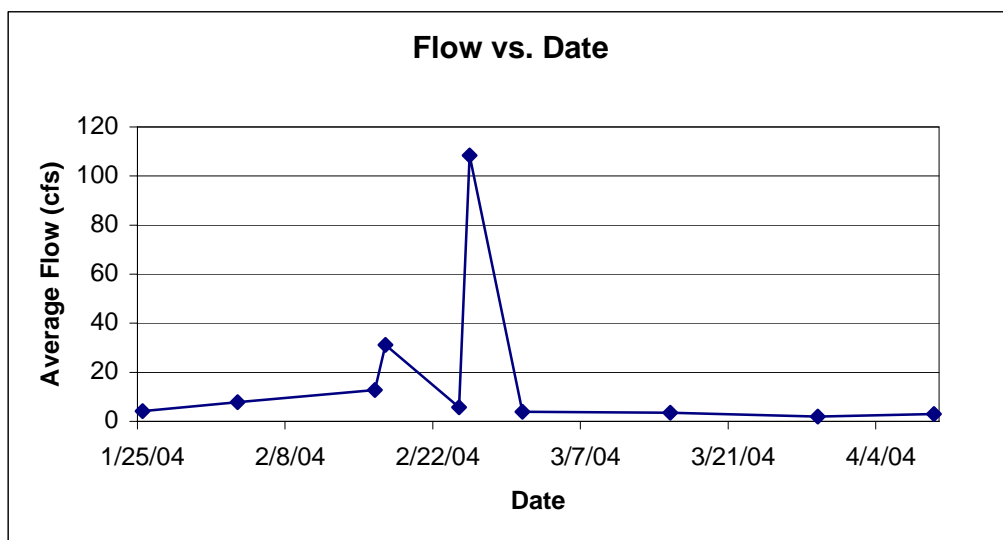
The flows peaked out at 153 cfs during the largest storm event of the season (fig. 2). Pre-wet season observations showed that this system seems to have a consistent base flow of approximately 1cfs (fig. 2).

Fig. 2 : 2004 winter-spring season hydrograph.

The data collected provides a graphical representation of the flow dynamics during the 2004 winter-spring season as the first analysis of the hydrologic character of the channel. The quality of this system can not factually be determined by these results, as it is extremely limited by only being collected during one wet season, and the enormous variability's, seasonal and yearly, of stream systems (Dunne & Leopold 1978). We can use this season as a proxy for an average season, and a first step in the complete analysis spanning many years. This certainly does not produce the most accurate representation possible, as a flow meter and/or hydrological gauge permanently placed in the channel could collect continuous flow data and give you the exact flow dynamics of the system.

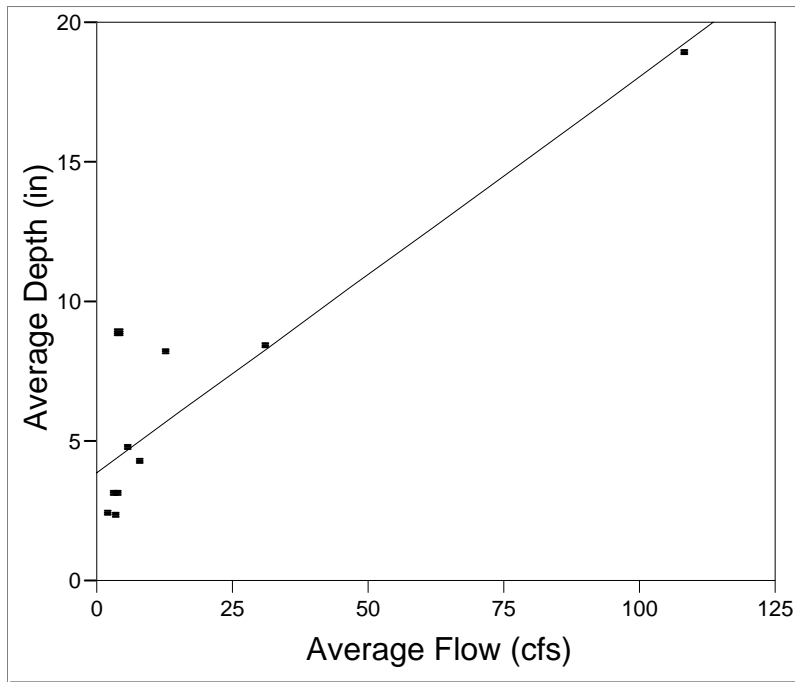
We observed a strong correlation between the depth of the water and the flow (fig 3). This made it possible to apply a linear regression as an approximate rating curve. Once gauged, flow can be estimated using the linear formula: Average Depth (in) = $3.9165667 + 0.1415054$ Average Flow (R^2 : 0.84).

Fig. 3: Rating Curve, Linear Fit of Depth (in) by Flow (cfs)

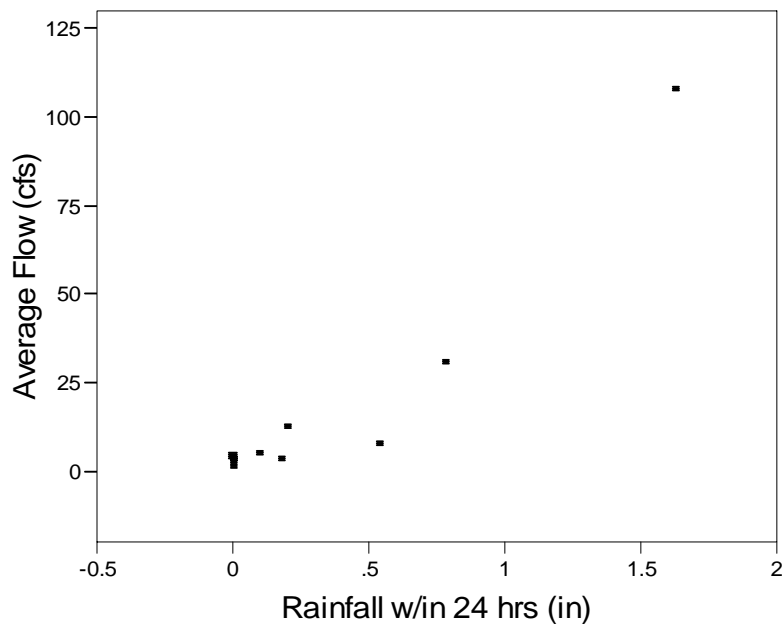
The flow plotted by the rainfall fallen in the area with in 24 hours of the data collection (NOAA Weather Page 2004) shows a quick response to precipitation and high discharge associated with less then 2 inches of rain fig. 4.

Fig 4: Average flow response to rainfall w/in 24 hours.

This association could be better explained with the installation of an onsite rain gauge, and a stage gauge in the channel recording continuously. The water quality parameters indicate that this is a healthy stream with respect to the variables collected in this project according to the EPA (EPA Website 2004). The large variation in turbidity can be explained by its association with flow, as one would expect larger flows during storms carry much more sediment (fig. 5). Very little sediment was observed in the channel so we must assume it is all being carried to the slough and marsh where it is deposited.

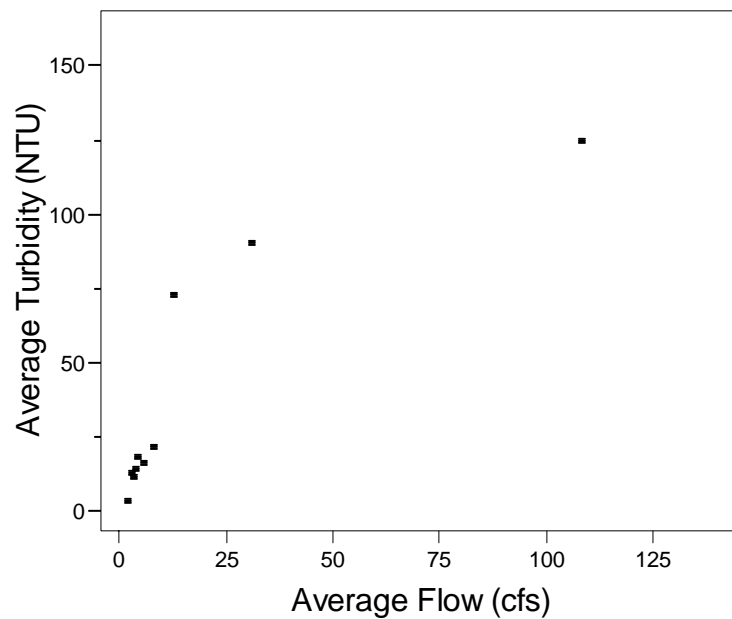
Fig. 5: Turbidity explained by discharge.

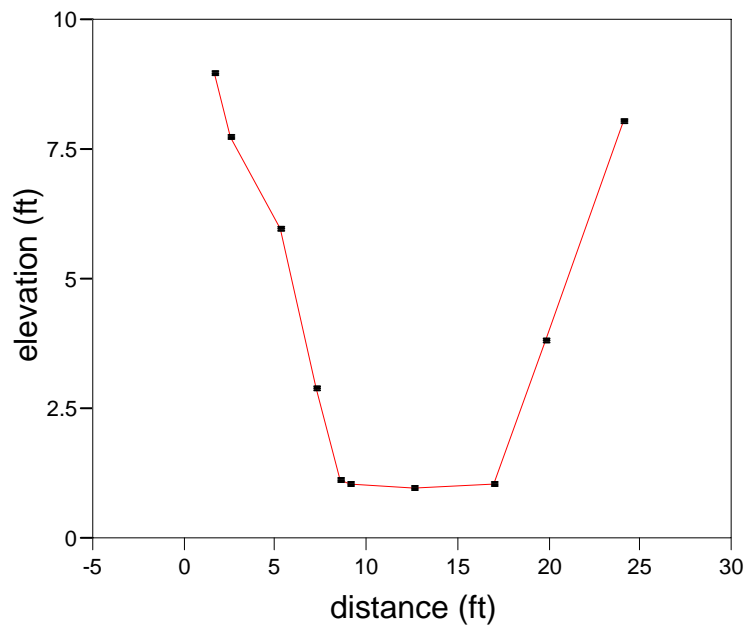
Fig. 1: Cross Section at Site 1

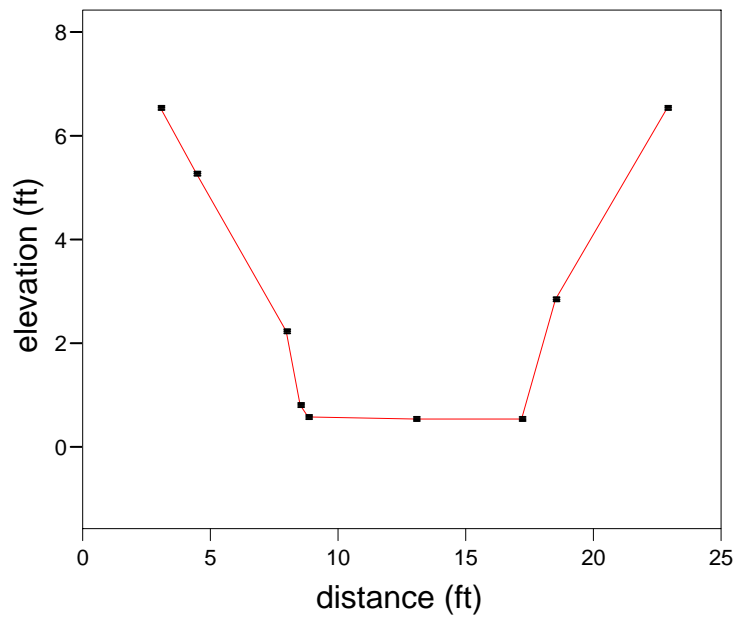
Fig. 2: Cross Section at Site 2

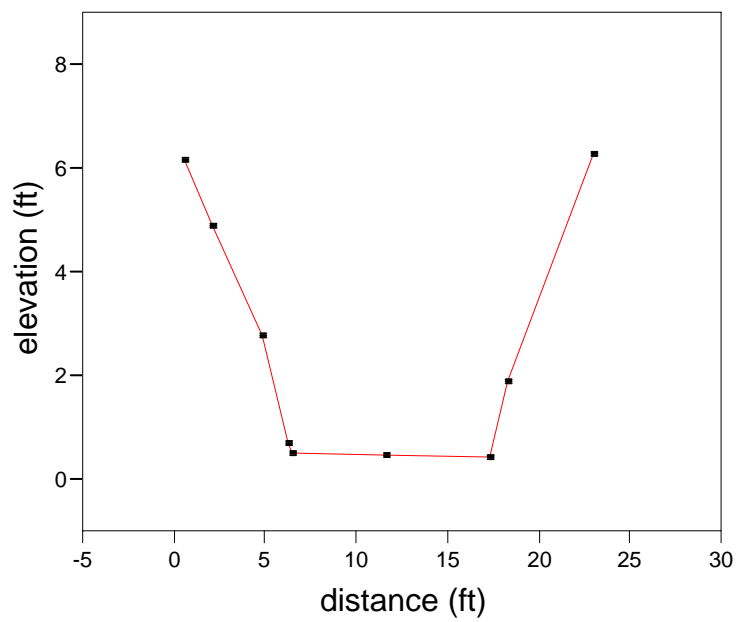
Fig. 3: Cross Section at Site 3.
