CHAPTER 2
THE IMPACT OF ORV USE AT ANTHONY CHABOT REGIONAL PARK

Geri Hecker

Site Description

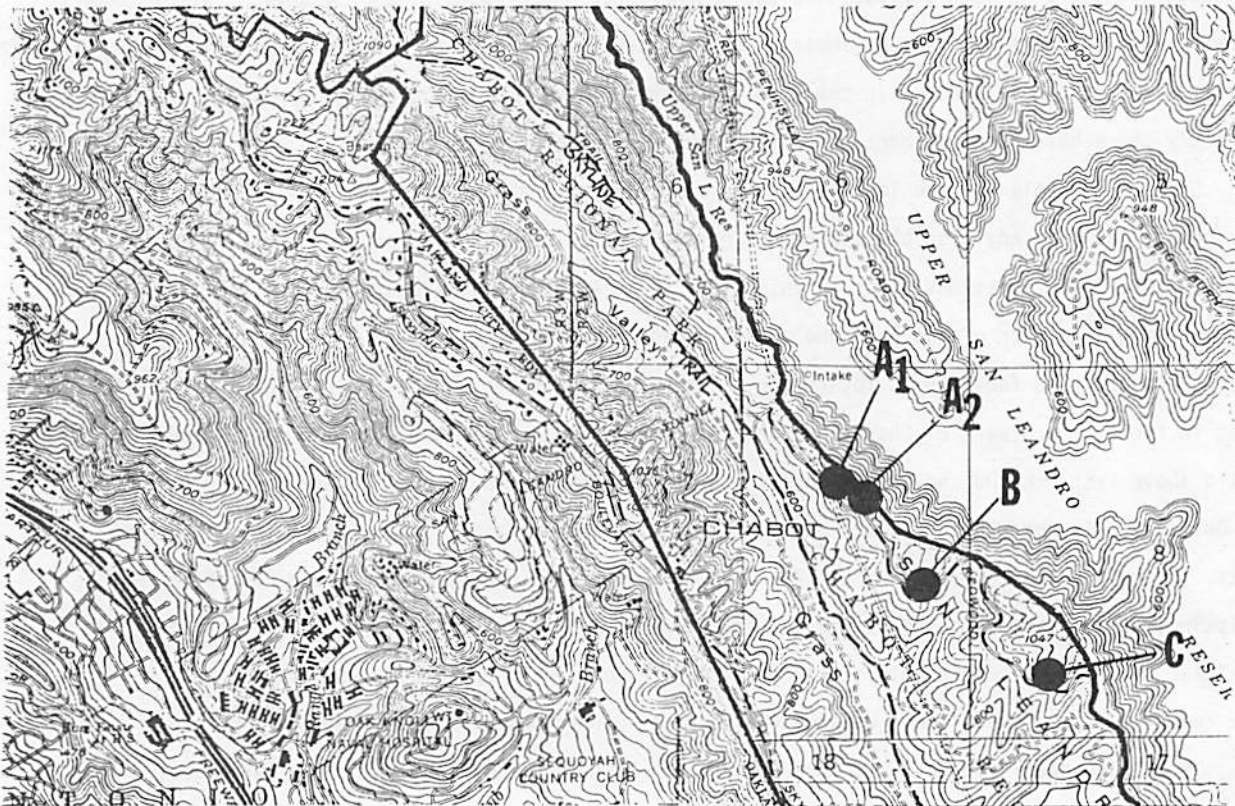
Figure 1. Site Locations in Chabot Regional Park
Source: Base Map from EBRPD

The motorcycle facility is located on a narrow coastal brushland-covered ridge just above Redwood Road in the northern part of Chabot Regional Park (Figure 1). The 4000 acre park is located in the hills above East Oakland and San Leandro. The facility was opened about 20 years ago specifically as an ORV site. In recent years EBRPD has disclaimed knowledge of, or responsibility for, the area. In fact, in the December 4, 1973, Master Plan, under the heading "Regional Vehicular Recreation Areas - Existing," the Chabot ORV site is not listed. However, there is a sign on the site identifying it as "East Bay Regional Parks Motorcycle Facility." According to ORV users using the area at the time the report was published, there were up to 200 bikes per day on a sunny weekend at the site.

Area A (Figure 1) appears to be the area of earliest use. It is the area first approached when driving east on Redwood Road and has a sign identifying this as an ORV facility. The southeast facing slope, A₁, does have a fair chance for revegetation, although it has sustained severe impact. There has been colonization by some clumps of grass, and there is evidence that these grasses are holding soil and stabilizing some small gullies. The severe gullies, though, appear to be getting deeper.

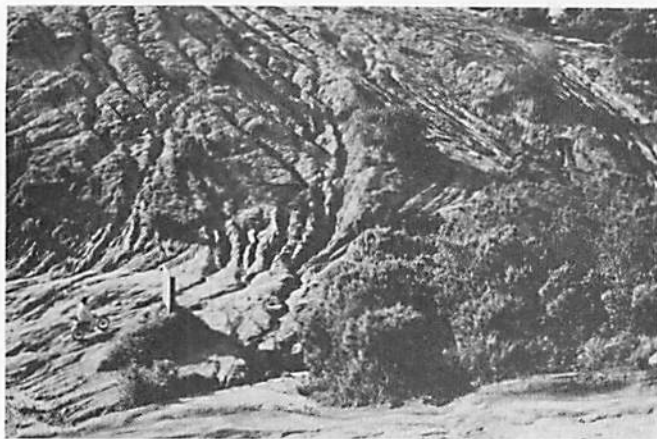
Figure 2. Slope A₁

The top area of the slope is mostly bare sandstone now while the bottom area does have some soil (Figure 2). There are small *Baccharis* bushes on the lower slopes and sides. It appears that in this area of the facility, *Baccharis* is very likely to become the dominant plant. The slope still has only about 5% plant cover, but is not used much by bikers, due to the severe gullies. In the last few months the amount of plant cover has increased, probably due to this winter's heavy rains. As long as there is no increased use of this slope by cyclists, the chances for revegetation are only fair, due to the existing soil condition and the continued erosion.

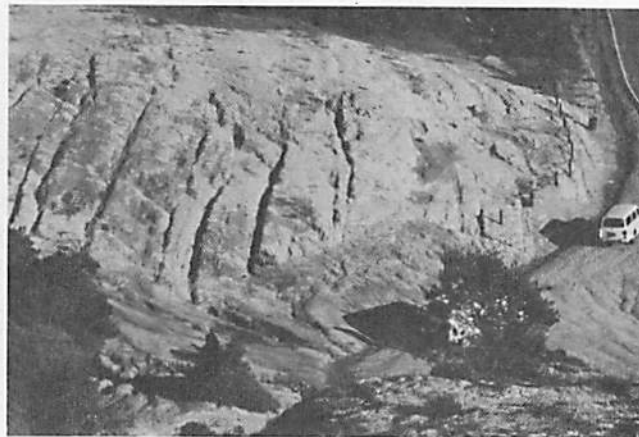
Figure 3. Slope A₂

Area A₂, which is a southwest facing slope, is separated from A₁ by a trail that leads to other trails in the site. Because of the condition of the two slopes and the proximity of a trail through to other trails, there is not much use of A₁ or A₂ by motorcycles. Area A₂ is now predominately bare sandstone (Figure 3). Even though A₂ is less steep than A₁, the erosional damage is more severe. There are very few grass clumps on the slope. There are *Baccharis* bushes very near A₂, but there does not seem to be much colonization of the slope by *Baccharis*. It appears that the chances for revegetation here are poor due to lack of soil in many places and the continued effects of erosion.
