THE RISING OF THE TIDE - A STUDY OF MARSH RESTORATION

Stuart Siegel

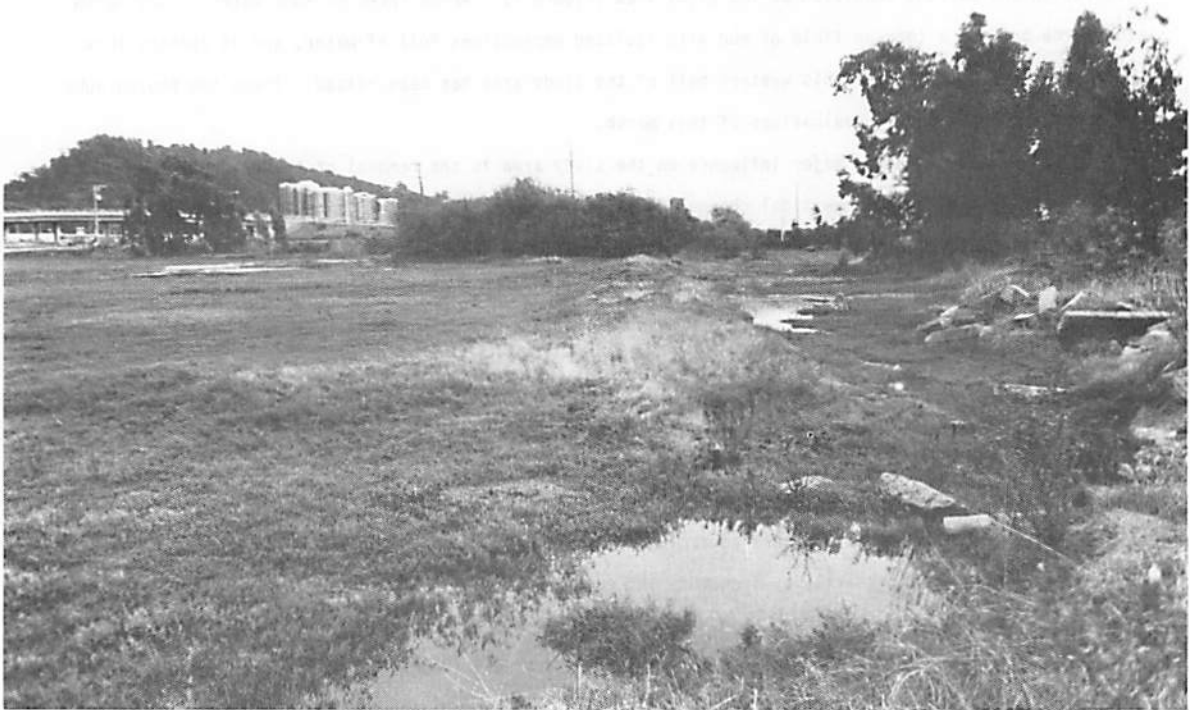
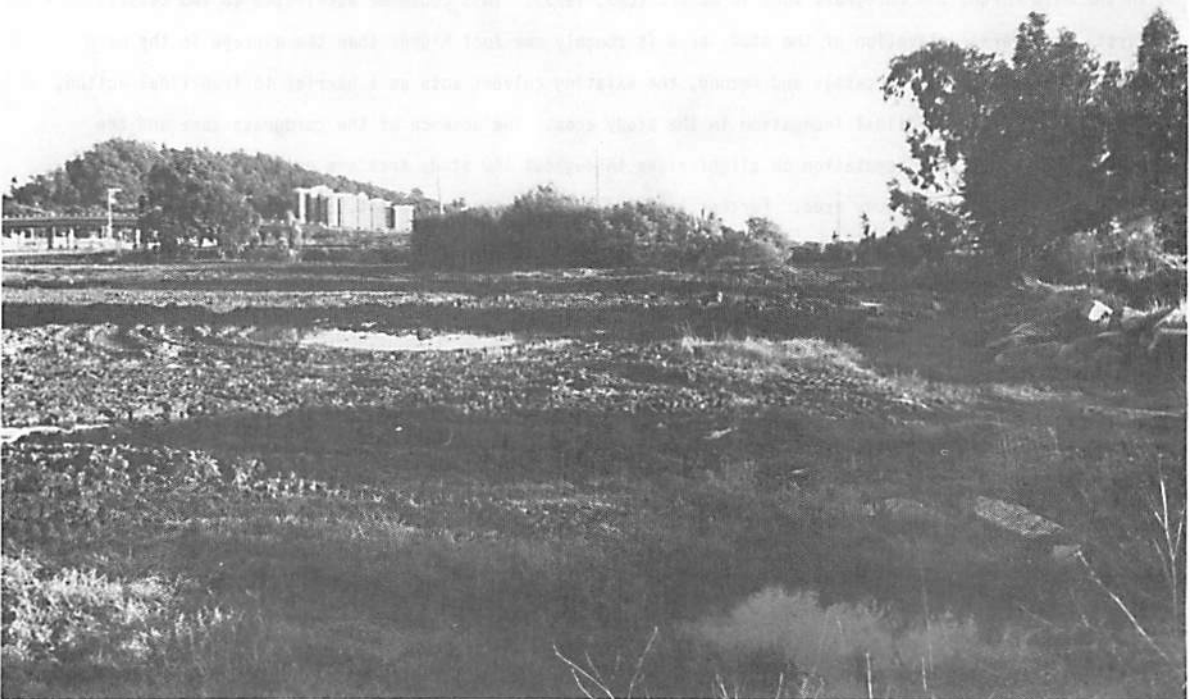
The dramatic changes that have occurred in the marsh are shown in the photographs of the before-restoration and current condition of the study area (Figure 4). About three or four acres of the marsh study area are now a torn-up field of mud with isolated depressions full of water, and it appears that the elevation of portions of this western half of the study area has been raised. These two photographs would be useful for future evaluations of this marsh.

Figure 4. The Hoffman Marsh Before Restoration Began (Top, 10/28/84) and After Restoration Commenced (Bottom, 2/9/85).

A factor that has had a major influence on the study area is the removal of the dredge spoils that were created by digging the new tidal channels. The BCDC permit to Caltrans stipulated removal of the dredge spoils, as dredge spoils constitute unnecessary fill in the Bay. This condition is required by the San Francisco Bay Plan policies on marshes and on fill (BCDC, 1979). Heavy equipment used to remove the dredge spoils from the study area, however, resulted in the tearing up of the marsh surface (see photos) to the apparent detriment of this marsh habitat. In an attempt to minimize the impact, the contractor was allowed to place the remaining spoils onto the marsh surface (Michalak, personal communication, 1/85). This activity has resulted in a rise in marsh elevation, particularly along the western side of the study area.

A dramatic change that has occurred in the study area is the destruction of the top layer of sediments throughout most of the mud-torn area. Loose loam to clay soils are best for marsh plant growth (BCDC, 1983b); such soils are like quicksand -- one sinks in when stepping directly on the soil. The entire marsh had such sediments. Now, however, the three or four acres of mud-torn sediments in the study area, which receive little or no tidal inundation and bake in the hot sun, have lost most of their water content and have become very compacted. The bulk densities of the sediments in the study area have been found to be as much as twice that of sediments in the main marsh (see Jim Machado's paper in this report). One can walk anywhere through this area and have no fear of sinking. Such clay soils, once compacted through evaporation, cannot revert to their original state, for water cannot easily penetrate the closely-packed clay particles (Sloan, personal communication, 4/85). Thus, reestablishment of vegetation could be hampered in the three- or four-acre impacted area.

the degraded marsh as is and install the additional culverts when the sewer pipe is replaced by its owner in five or ten years. This alternative neglects the value of the marsh. A third alternative, which I strongly advocate, is requiring Caltrans to do the following: (1) reduce the elevation of the restoration area to its original height; (2) check the existing culvert often (monthly), and clean out as necessary; and (3) install the additional culverts at the time of sewer pipe replacement. This alternative would allow nature to take its course without so many impediments, and could result in near-achievement of restoration goals throughout the study area even before the new culverts are installed.
