Channel Cross-Section Analysis in Alhambra Creek

Maureen C. Mason

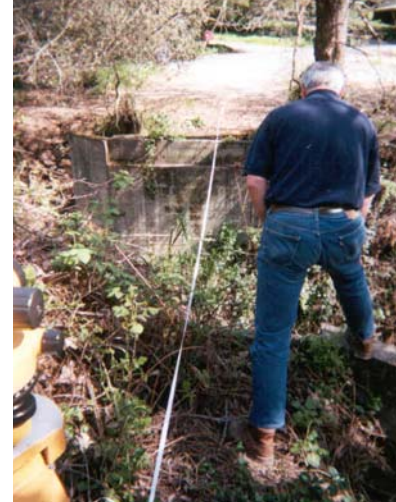
Figure 3. Cross-section 1 at former bridge abutment. 3/19/02.

Six of the ten cross-sections' channel morphology were likely influenced by anthropogenic in-stream structures. Cross-section 1 (Figure 3) is located at a former bridge abutment for a road that used to join Wanda Way to the Muir-Strentzel gravesite (a National Park Service property). The width is obviously constrained by the bridge foundations, while the depth has increased by 1.45 feet.

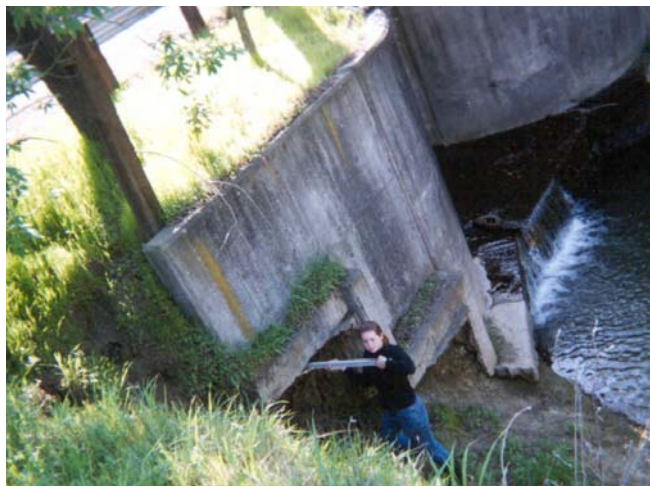
Figure 4. Erosion at downstream end of Alhambra Avenue bridge, right bank. 3/3/02.

Cross-section 6 is located 40 feet downstream of the Alhambra Avenue bridge, which forms a 10 by 10 feet culvert. Approximately 1.4 feet of erosion was measured at the right bank bridge foundation on 3 March 2002 (Figure 4). This erosion is most likely due to a combination

of channel adjustment following incision and the hydraulic effects of the small culvert. Erosion was evident on both banks, although the left bank represents more of a concern for property-owners. Figure 5 shows a temporary solution to this problem, in the form of a tarp covering secured by rope and tires. Both the channel width and depth have increased at this cross-section, by 2.9 and 4.24 feet, respectively.

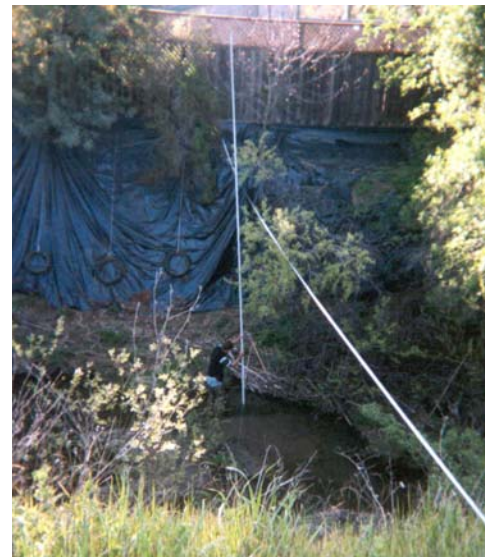
Figure 5. Bank erosion at cross-section 6. 3/19/02.

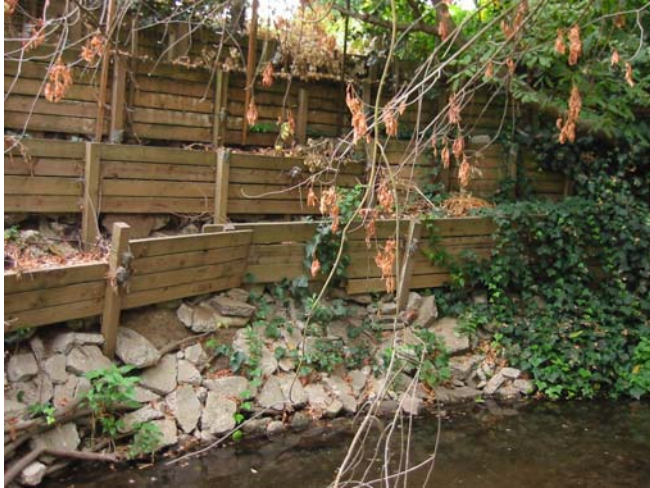
Figure 6. Crib walls and rip-rap near cross-section 8.
10/28/01

Cross-sections 7 and 8 are located farther downstream in Reach 2, where the use of crib walls and rip-rap to control bank erosion is prevalent. Sagging wooden crib walls and scattered chunks of concrete typify the bank composition in this reach. Figure 6 shows the right bank at cross-section 8, where four wooden crib walls and pieces of rip-rap (of unknown installation date) exert an influence on the channel morphology. Width and depth changes between these two cross-sections were variable, while decreases in these dimensions may be attributable to bank-stabilizing structures.

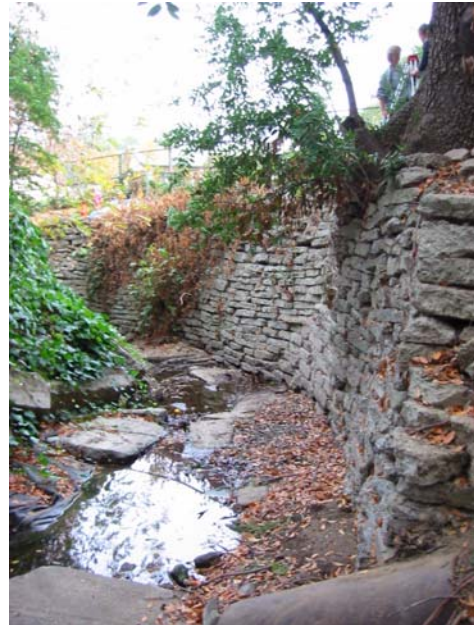
Figure 7. Concrete wall at cross-section 9.
10/28/01.

The morphology of cross-sections 9 and 10 appears to be heavily influenced by the presence of a large wall of concrete pieces that comprises most of the right bank in the vicinity of these cross-sections. Historical survey data for these locations shows a much wider channel with a higher right bank. I speculate that the right bank was graded for development following the 1955 survey, and then further reshaped during the construction of the wall (about 5 years ago). Figure 7

shows the wall on the right bank, looking downstream near the location of cross-section 9. Note the large concrete chunks in the channel bottom that were placed to stabilize the creek elevation at that point.
