Applicability of Remote Sensing Data to Rapidly Assess River Restoration Sites in the Palo Verde Valley

Brian J. Gong

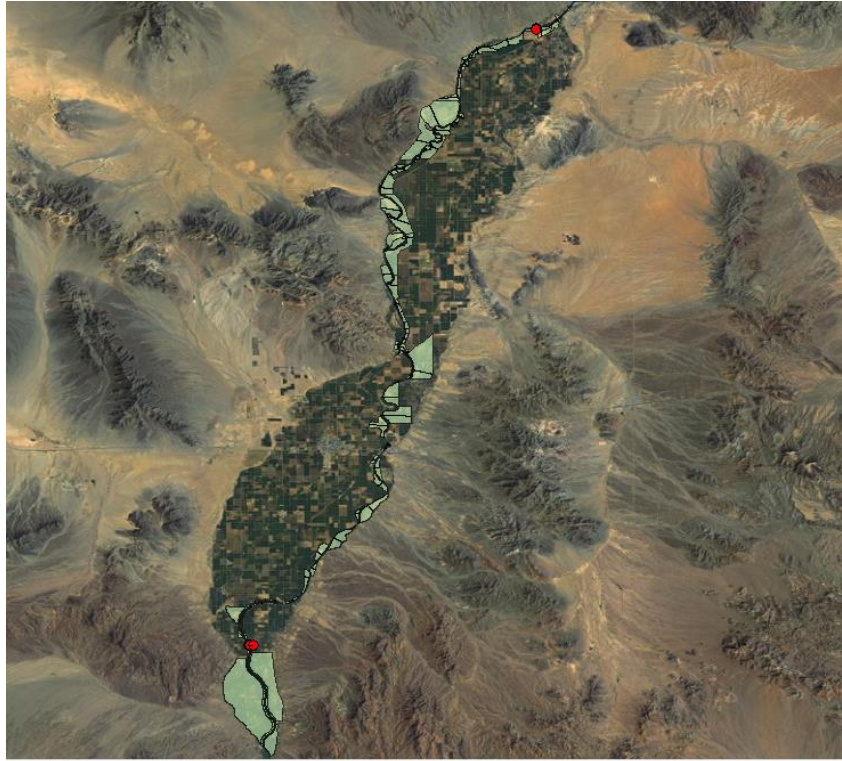
Figure 1. Locations of sites. Field sites are located as the two red points, while remote sensing sites are shown as green polygons.

To verify methods evaluated from remotes sensing data, I used field measurements. I acquired two field elevation cross sections from my lab group. A site map shows the locations of the surveys below (Figure 1). I used the “Profile Graph” function of ArcGIS to extract the same

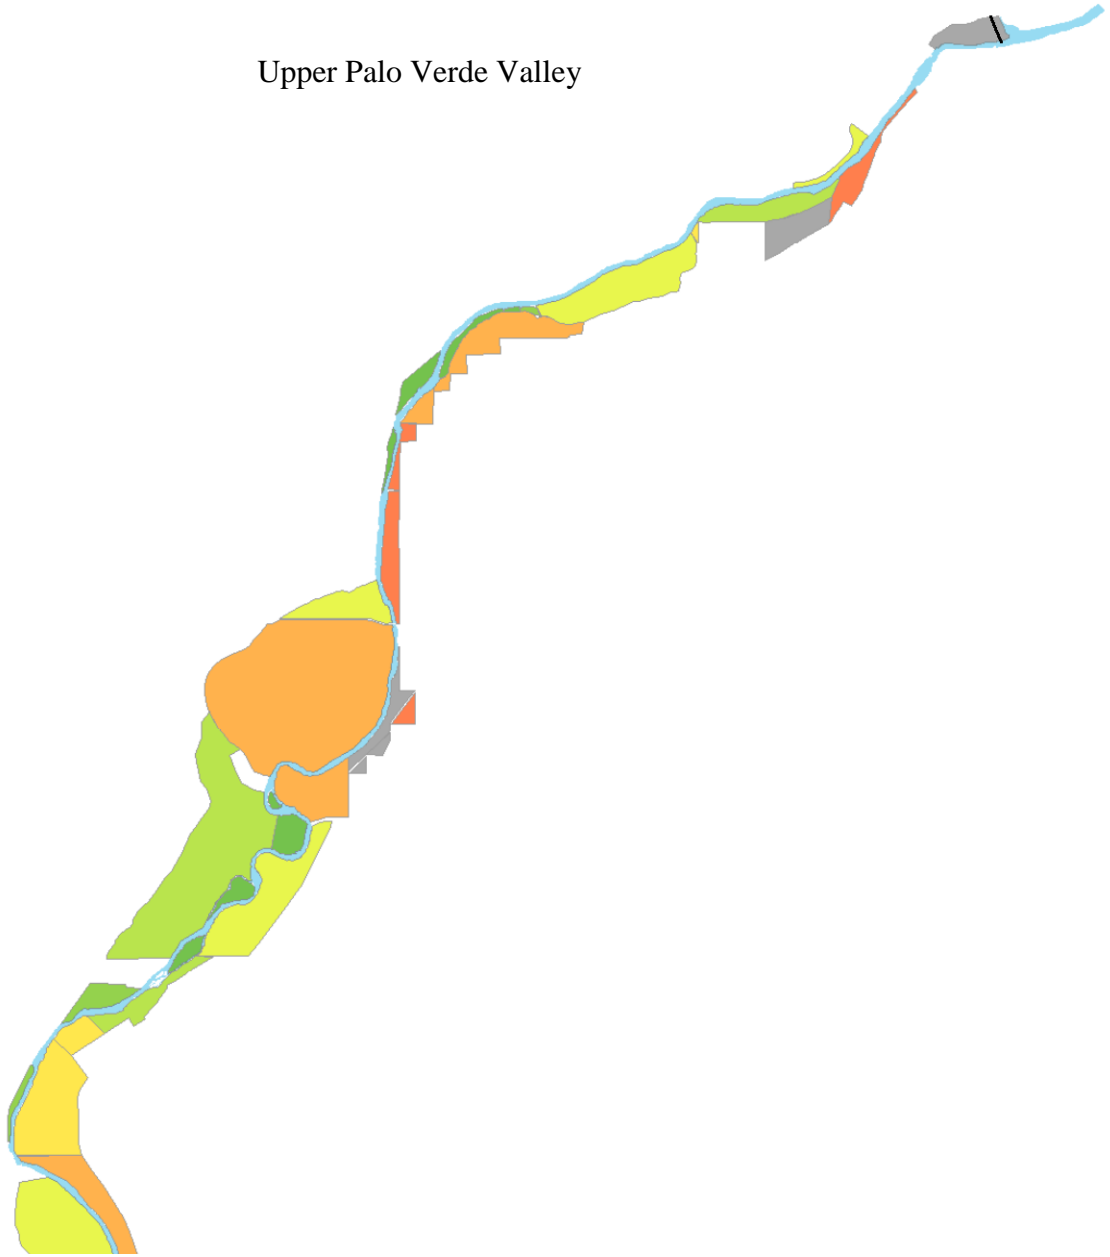
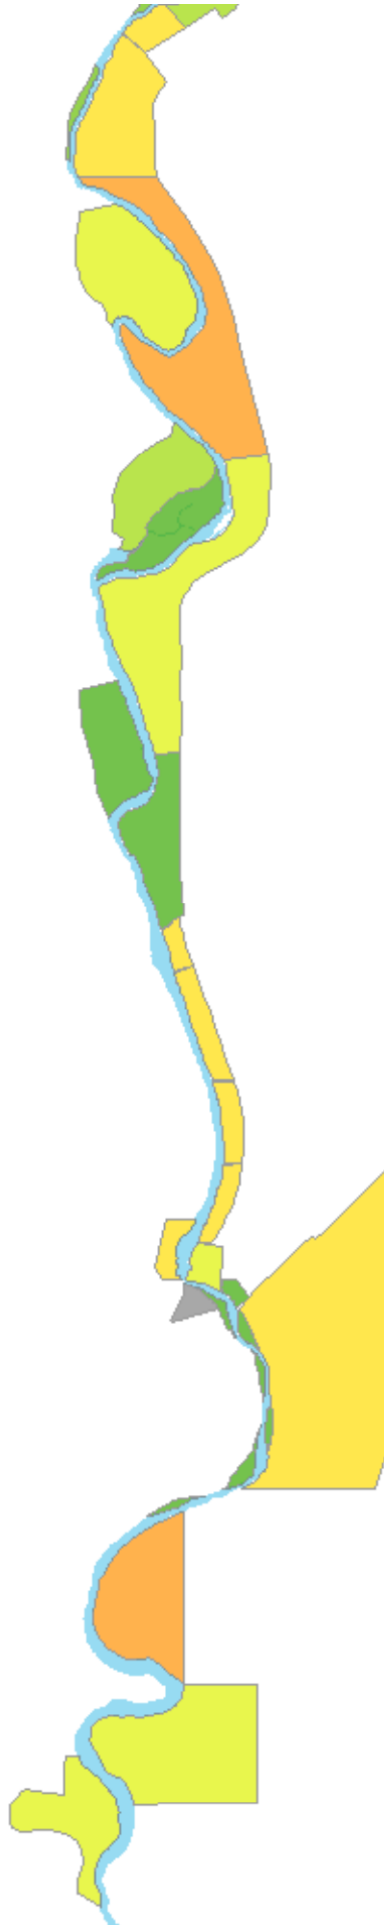
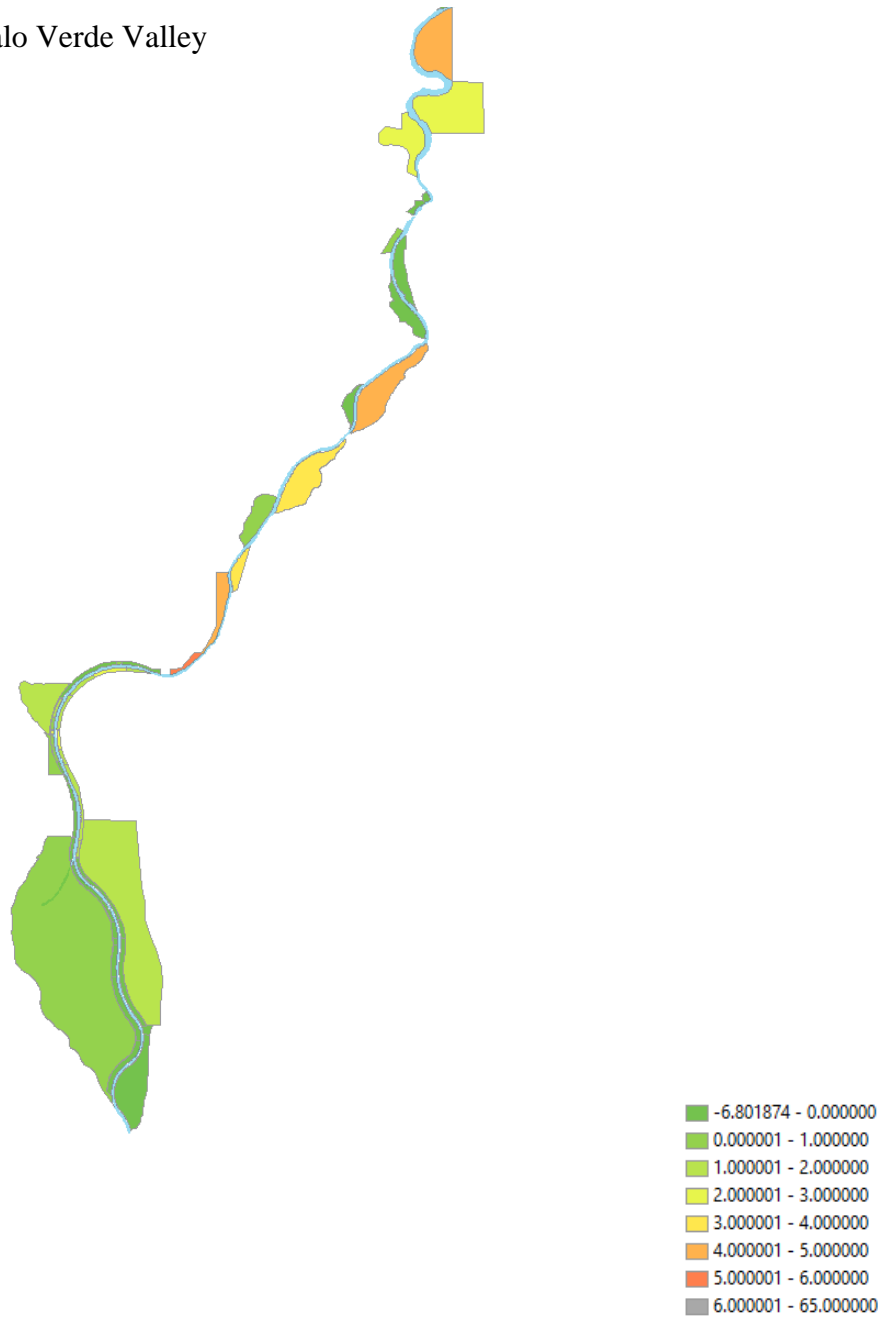
Figure 4. Site maps of the Palo Verde Valley. This map includes all sites, with some overlap in order to give spatial perspective. Sites that scored low are in green. Sites that scored high are in red and grey.

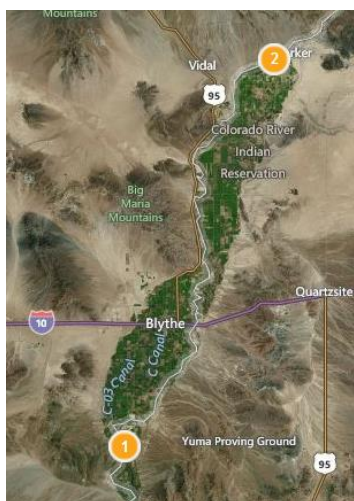
Figure 5. Site map of sites analyzed using field data. Marker 1 shows site 35 while marker 2 shows site 71.

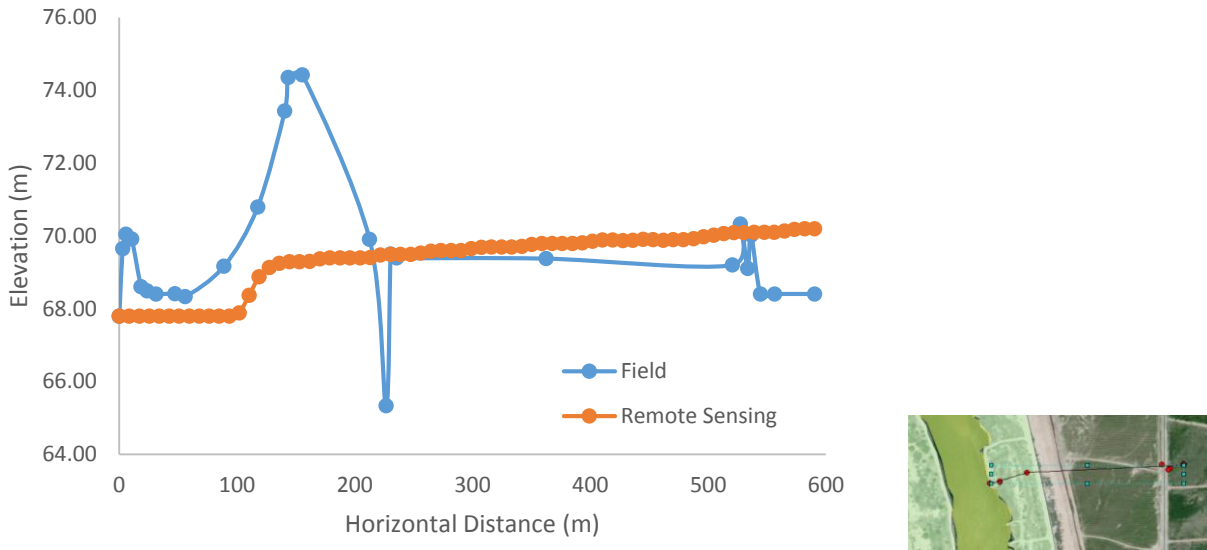
Figure 6. Comparison of elevation cross sections for site 35. On the right is a picture of the site. Both field and remote sensing results are included.

Using field data, I analyzed two field data sites, sites 71 and 35 (Figure 6, Figure 7). Site 35 was an LEV site located in the lower Palo Verde Valley. This site follows the river with a small amount of land extending back from the river. This site mostly consisted of a levee system holding back the river, with adjacent fields that were below the river level (Z. Rubin, *personal communication*). At Site 35, the largest deviation between the remote sensing data and field data about 5.1 meters (Figure 6). Site 71 was an IRR site located in the upper Palo Verde Valley. This site consisted of an area with a water feature in the middle of the site. The largest deviation between the field and remote sensing data was estimated to be 1.5 m (Figure 7).

LEV sites demonstrated good restoration potential as a result of being close to the river with low elevation. LEV sites did not extend away from the river enough to experience sharp elevation increases. LEV sites perform well with a little variation as suggested by a mean suitability analysis score of 0.5 and a standard deviation of 1.5 (Table 3). This is also supported by the range of 6.0 (Table 3). The difference between the mean and median is caused by a few larger positive outliers skewing the data. This may have been because many of these sites were located in the lower Palo Verde valley while a few poor performing sites may have been located elsewhere. Based on the conclusions for site #35, it appears that remote sensing can predict restoration. The site had an overall low elevation, which was captured in the DEM. However, the DEM failed to capture a tall levee that held back the river channel. Instead, it portrays an elevation increase, as if the site had been smoothed over (Figure 6).

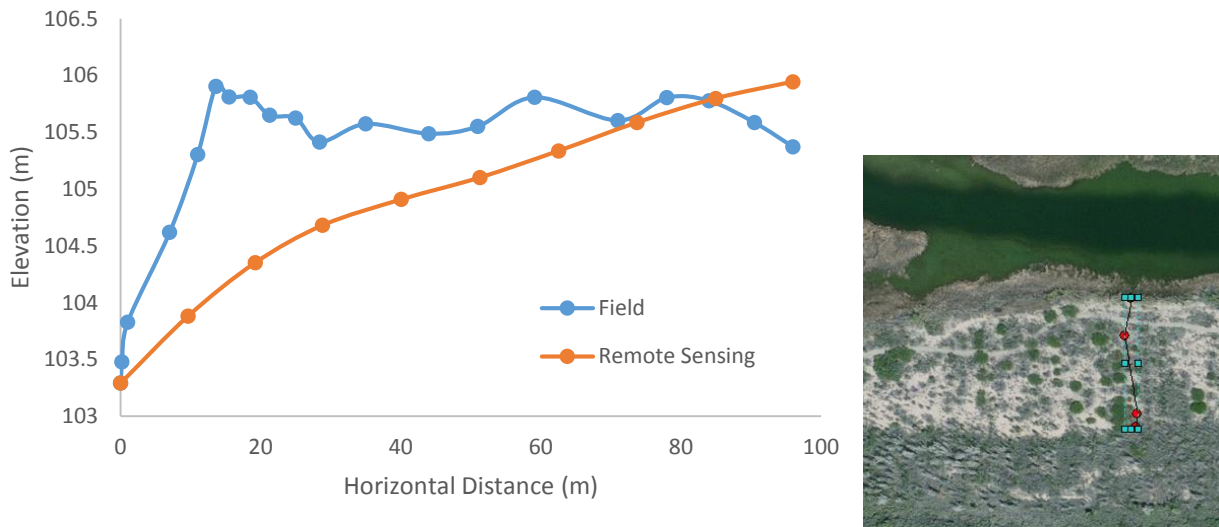
Figure 7. Comparison of elevation cross section for site 71. On the right is a picture of the site. Both field and remote sensing results are included.

IRR sites demonstrated below average restoration potential as a result of high elevation differences with the river. The mean suitability analysis score of 2.3 and a standard deviation of 2.6 suggest that IRR sites are not as suitable for restoration as the other site types (Table 3). In general, IRR sites that performed well were located in the lower Palo Verde Valley. High performing IRR sites in the lower Palo Verde Valley had low elevation differences with the river. Poor performing sites were located in the Upper Palo Verde Valley. IRR sites showed high variability due to the wide range of shapes and geography of each site. Based on site 71, it appears that the remote sensing data was a reasonable approximate for field conditions. The remote sensing data did not perfectly capture the elevation, and instead seemed to represent general trends in elevation change, with the nuances smoothed over. Because the largest deviation between the two was only about 1.5 m, remote sensing data can be used in order to predict site elevation (Figure 7).
