Chapter 1  
THORNTON BEACH LANDSLIDE:  
A CASE STUDY IN COASTAL DEVELOPMENT  
Paul Berkowitz

In this report I use the Thornton Beach landslide to illustrate the geologic hazards of coastal development in unconsolidated sedimentary rock. I will do this in two ways. First, I will describe the past impact of the landslide upon development; and second, I will map the erosion of the past 15 years in order to illustrate recent damage and to predict future damage.

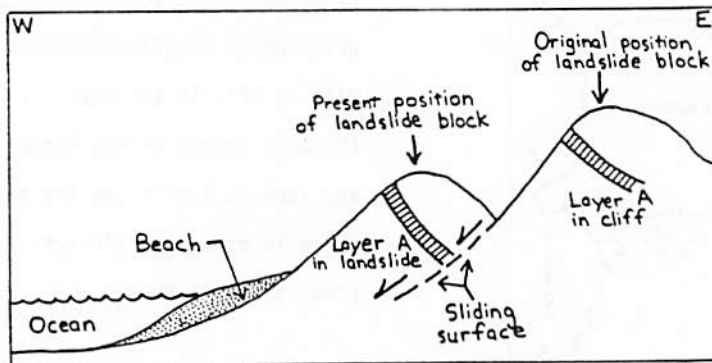
In the Thornton Beach region, and elsewhere along the coast, the typical kind of landslide is known as a rotational slump. This type of landslide involves the rotating and falling of a whole section of earth (Figure 2). As the landslide moves downward and outward, potential energy is converted to kinetic energy and friction (Schlocker, 1974). Consequently, the resulting slope has less potential energy, and is therefore more stable. Along the coast the stability of a slope changes rapidly. As soon as a landslide stabilizes a slope, wave erosion begins to remove the lateral support, creating yet another unstable condition. In the Thornton Beach area, wave erosion is particularly important in the winter, when the narrow width of the beach offers little protection from the powerful winter waves.

Figure 2. Schematic drawing of rotational slump.  
Source: After Liston (1976).
