## **Restoration Recommendations for Fish Species Re-population of Strawberry Creek based on High Flow and Stream Habitat Assessment**

**Cheryl Lee**

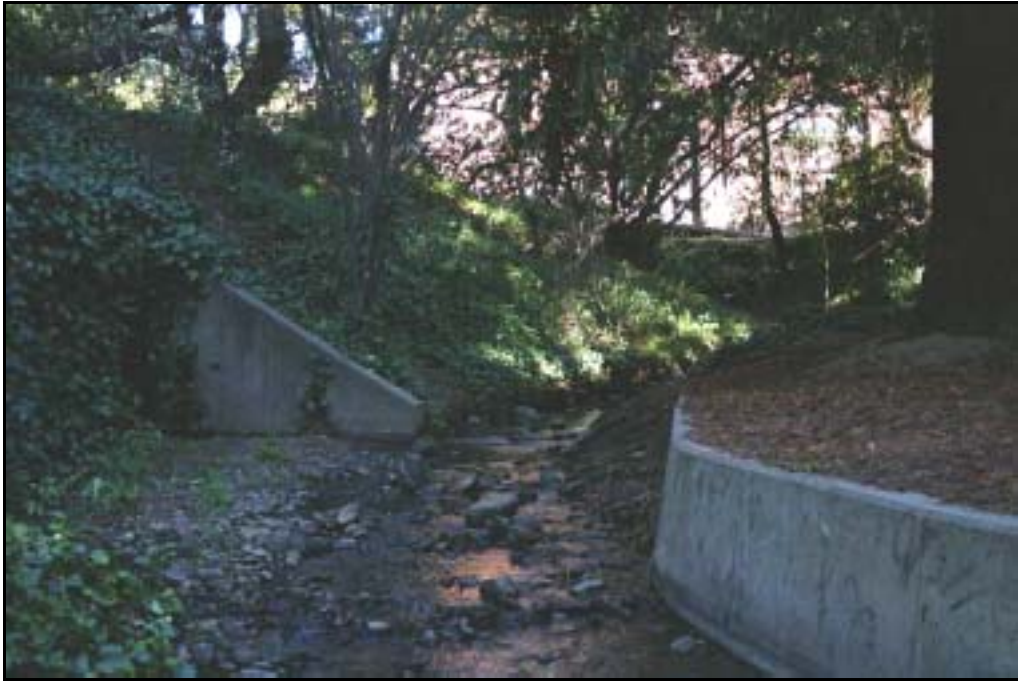
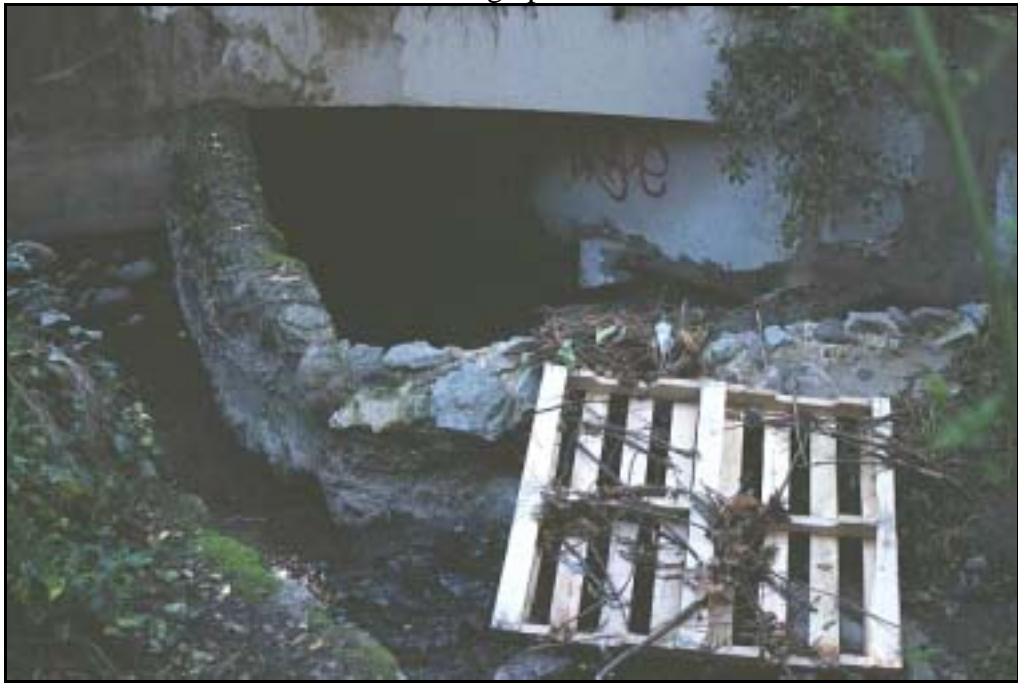
Site 4: South Fork – Sather Gate, Box Culvert Bypass

Looking downstream, on the left is the bypass channel, on the right is the box culvert
