CHAPTER 2
RESIDENTIAL CONCERNS FOR SEISMIC SAFETY

Introduction

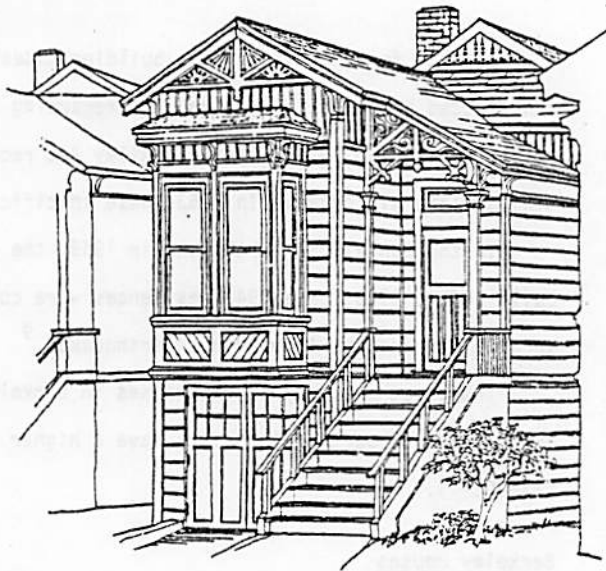
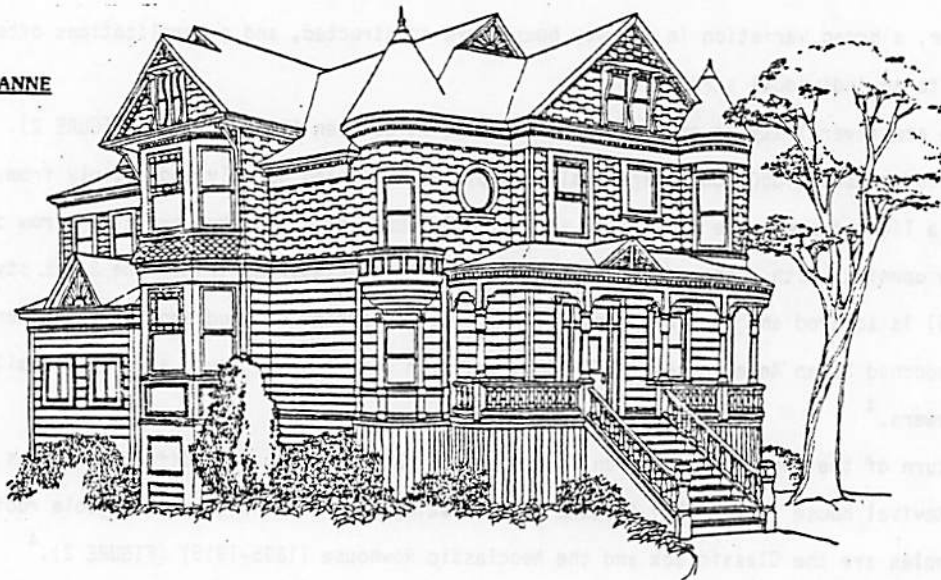
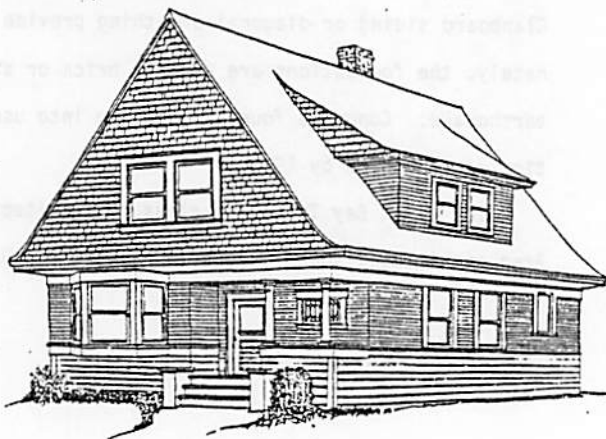
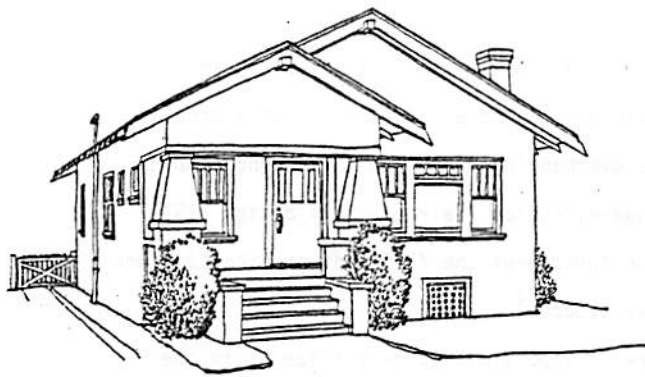
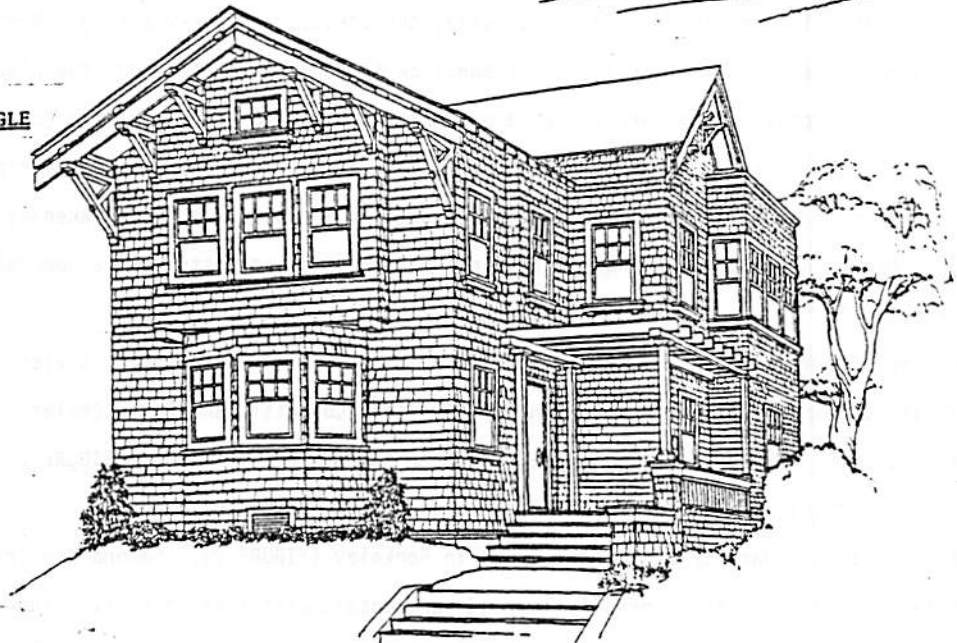
FIGURE 2: Berkeley Architecture
SOURCES: City of Oakland Planning Department,⁴
Berkeley Architectural Heritage
Association¹

There are several styles of Victorian house, built between 1850 and 1900 (FIGURE 2). The early Pioneer houses (1850-1885) were small and plain, assembled quickly and cheaply from 2x4's nailed to a light frame. The Italianate style (1860-1885), distinguished by tall narrow door and window openings with rounded arches, features ornate brackets and trim. The Stick style (1870-1895) is squared and angular, decorated with narrow strips of wood and carved patterns. The well-adorned Queen Anne houses (1870-1895) are rich with gables, bays, and occasionally rounded towers.⁴

The turn of the century brought on a less embellished styling. The different styles of Colonial Revival house (1890-1915) (FIGURE 2) is distinguished by a high-peaked gable roof. Other examples are the Classic Box and the Neoclassic Rowhouse (1895-1915) (FIGURE 2).⁴

industrial materials such as concrete or asbestos. Decorative detailing is no longer seen (FIGURE 2). The Brown Shingle (1890-1915) has a plain design and a natural looking siding. Characteristic of the Craftsman (1905-1925) are wide overhanging beams and eaves, and combinations of natural untreated materials. The plain, square, stucco Prairie School design (1910-1925) is inspired by Frank Lloyd Wright. Very common throughout the flatlands are the California Bungalows (1910-1925), small, box-shaped, and usually stucco.⁴

The Period Revival buildings (1900-1955) are imitations of various past styles. Among them are the English-Tudor, French Provincial, American Colonial, and Swiss Chalet. The English Cottage is common in North Berkeley. The Mediterranean style (1915-1935) (FIGURE 2), with stucco walls and Spanish tile roof, was often used for apartment buildings.

There is a wide variety of Modern houses in Berkeley (FIGURE 2). Second Bay Tradition buildings (1930-present) are generally low and horizontal, with flat, tightly-joined redwood or plywood siding. They are distinguished from Suburban houses (1945-present) by their sophisticated handling of materials. Wood or aluminum siding is generally used in the Suburban houses. The Multi-Unit buildings (1945-present) generally use stucco, flagstone, brick or masonry block exteriors, and outside steel frame stairways with cast-concrete steps. The Third Bay Tradition (1960-present), vertical boxes with wood siding and broad terraces or square bays, are often found in the hills.¹
